Inspection Report

1 Good Home Inspection

Inspector: William Stowell

Inspection Date August 4, 2022

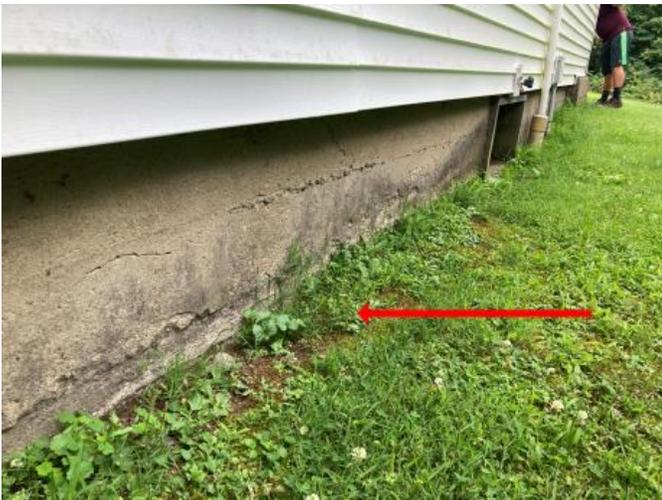
Minor re-grading near the foundation was observed. We recommend re-grading to assure all water drains away from the home's foundation. Failure to re-grade low-lying areas at the foundation can cause water seepage under slabs, into the basement / crawlspace, and / or cracks or movement in the foundation. Recommend necessary repairs by a qualified contractor.

Grade sloping toward foundation

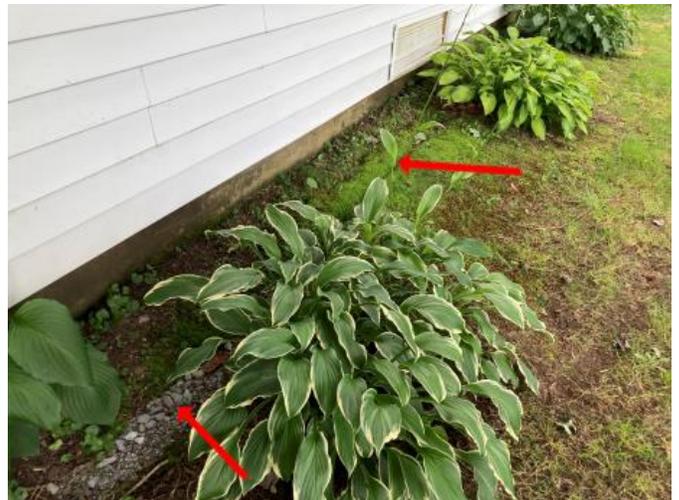
Rain line and low area next to foundation.

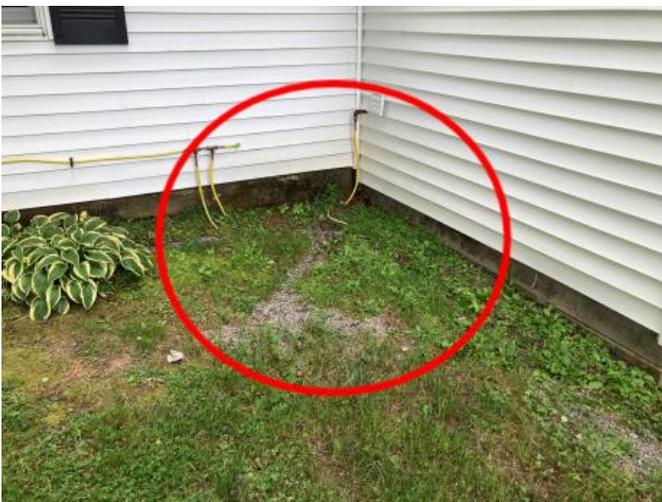
Low area by foundation shows signs of ponding.

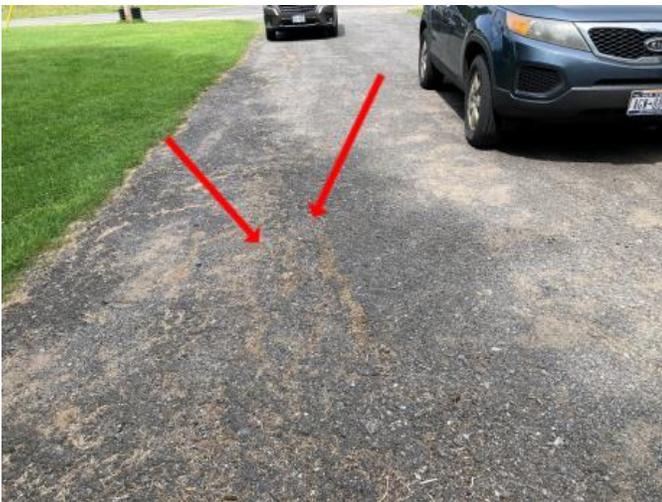
The driveway appears to be approaching the end of its useful life.

Cracks in asphalt

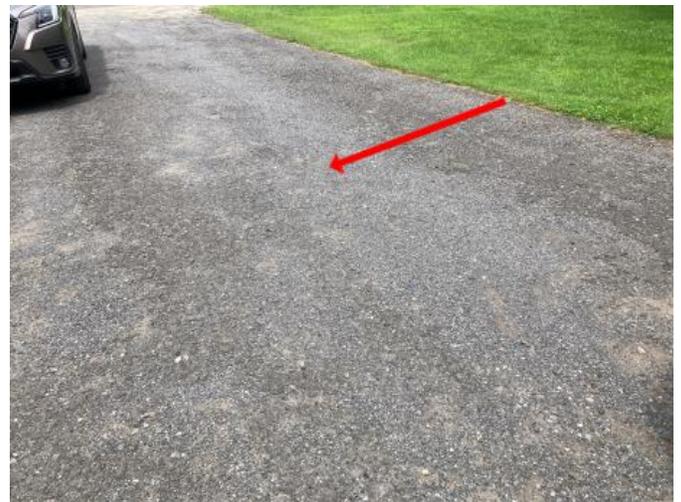
Asphalt showing loose gravel

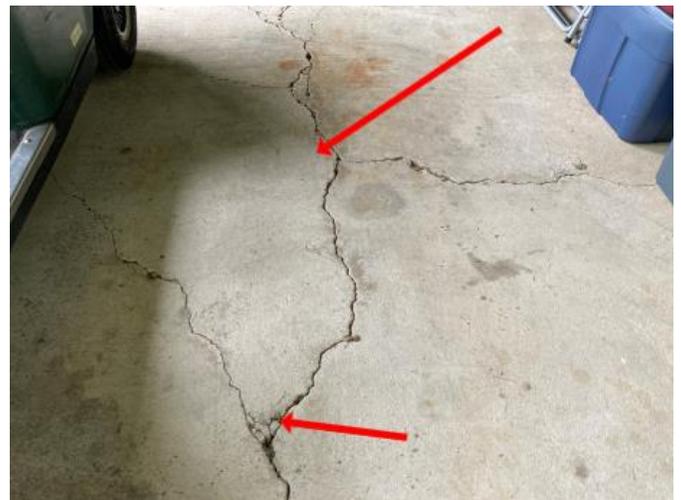
Rear entry covered patio concrete slab has some cracks. Cracks don't appear to be a trip hazard. Would recommend maintenance of filling cracks with urethane caulking to keep water from penetrating.

Cracking in patio concrete

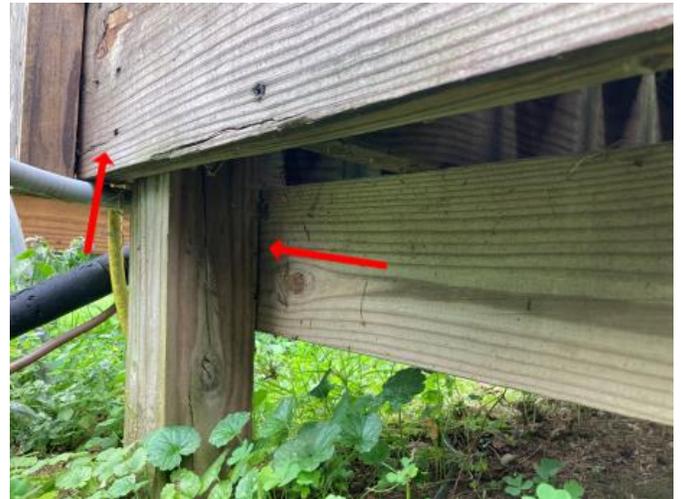
Appears Serviceable. However, the ledger board and support beams are nailed to the house and support posts. It is recommended these be fastened with approved lag screws. Recommend necessary repairs by a qualified contractor.

Support beam on rear deck nailed to support posts.

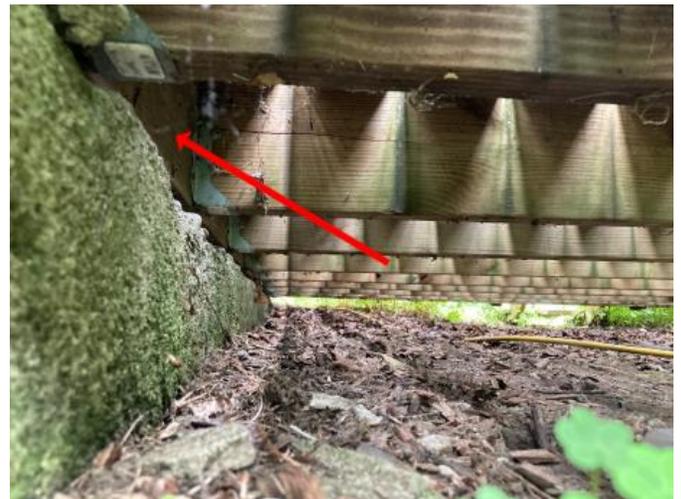
Rear deck ledger board nailed to house - should be lag screwed.

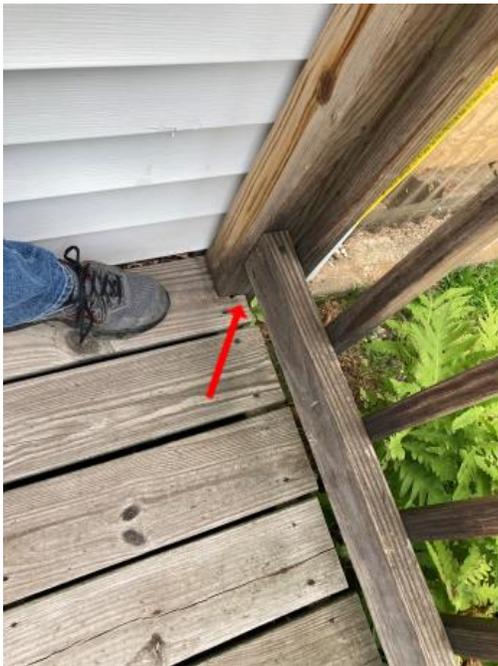
Rear deck has a loose guard rail post next to the house on the right side. This can allow the railing to fail resulting in a possible fall hazard. Recommend necessary repairs by a qualified contractor.

Guard railing on back deck loose

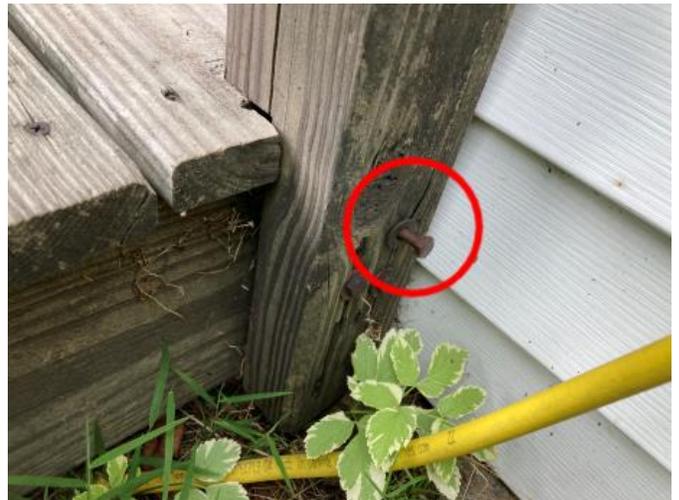
Loose bolt holding guard railing post

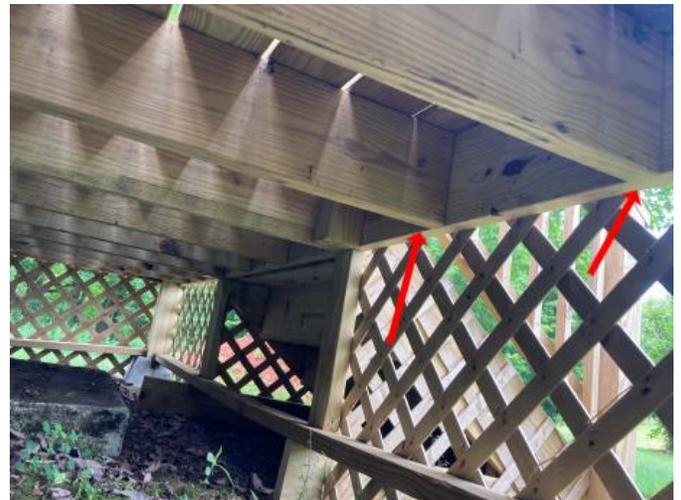
The front entrance decking ledger board is nailed to the house. Recommend using approved lag screws. Rim joists are nailed to the support posts. Recommend using approved lag bolts/screws. Floor joists are missing joist hangers. These corrections will help ensure the deck doesn't fail. Recommend necessary repairs by a qualified contractor.

No joist hangers on front entrance porch deck

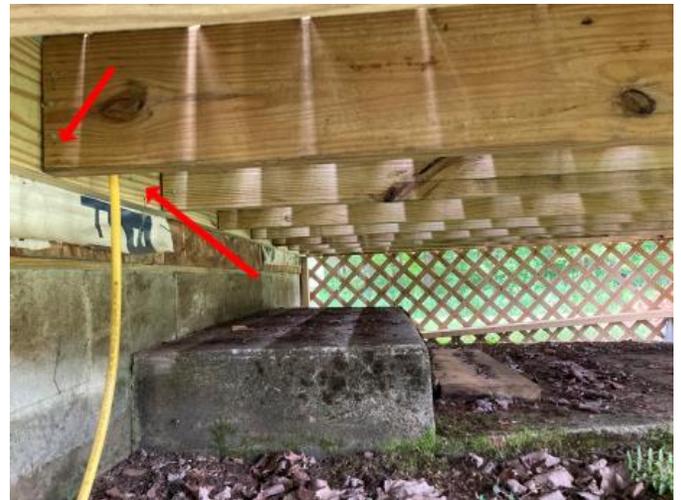
Ledger board nailed to house - recommend lags. Also, no joist hangers.

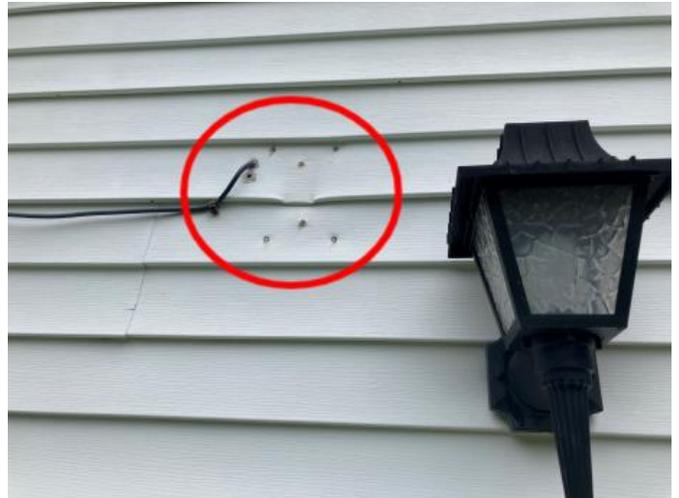
A few cracks and holes found in siding. These can allow moisture intrusion. Recommend necessary repairs by a qualified contractor. and damage to inner wall covering.

Holes in siding (patched)

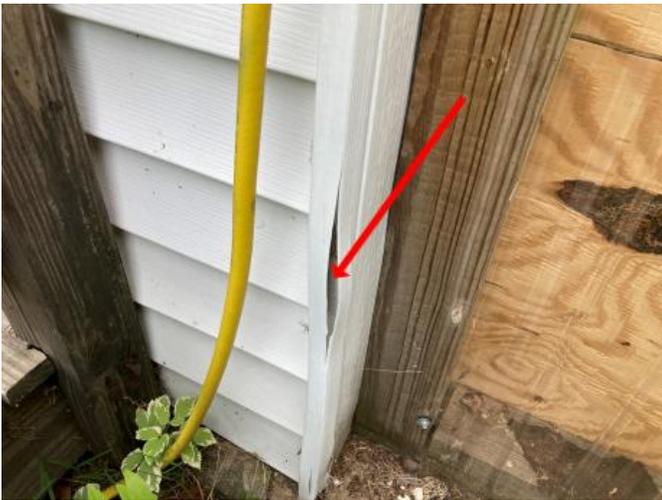
Damaged J channel on siding.

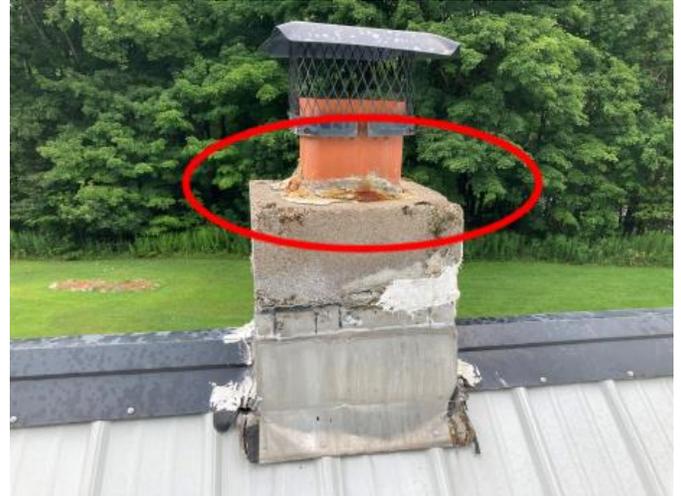
No chimney crown

Not noted. Chimney crowns help shed water away from chimney structure. Recommend qualified contractor evaluate and make necessary repairs.

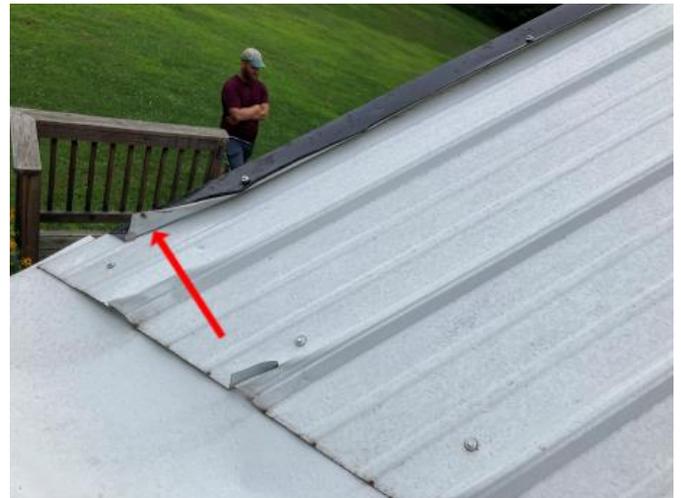
Observed some damaged gable end roof trim and some loose metal roofing. This may have been from ice damming (see sample picture). Ridge cap is in need of sealing. Roof metal was incorrectly lapped during install. A hole was observed around one of the metal roof fasteners. These can lead to water intrusion and damage. Recommend further evaluation and necessary repairs by a qualified contractor.

Some damage (Ice??) to fascia metal trim

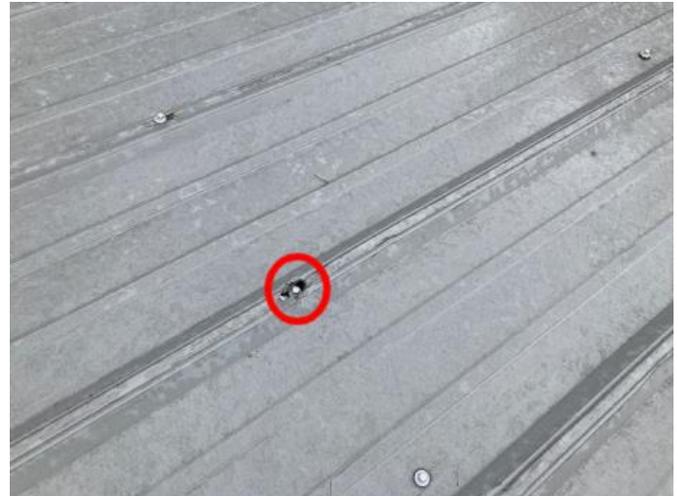
Hole around screw fastener.

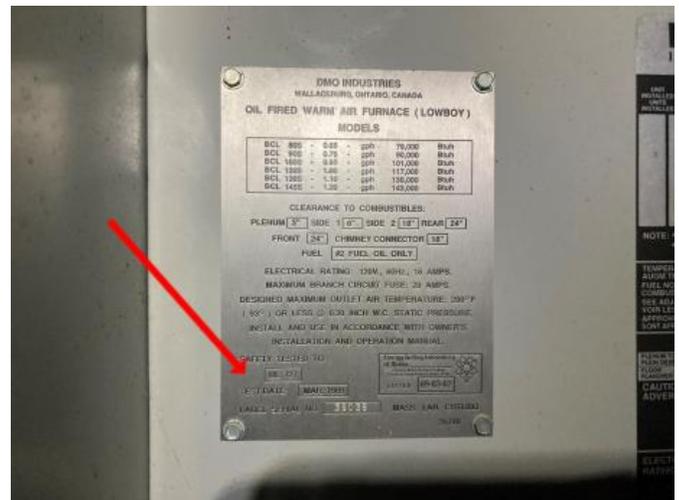
Unit had a damaged air filter. Unit had a 1994 Install date handwritten on the cover. Data label had manufacture testing date of 1989. It didn't appear there was a place (bracket) to properly hold the filter. No filter track / holder was noted. In order for the filter to be effective, recommend installation of a filter track. Recommend necessary repairs by a qualified contractor.

Manufacture testing date.

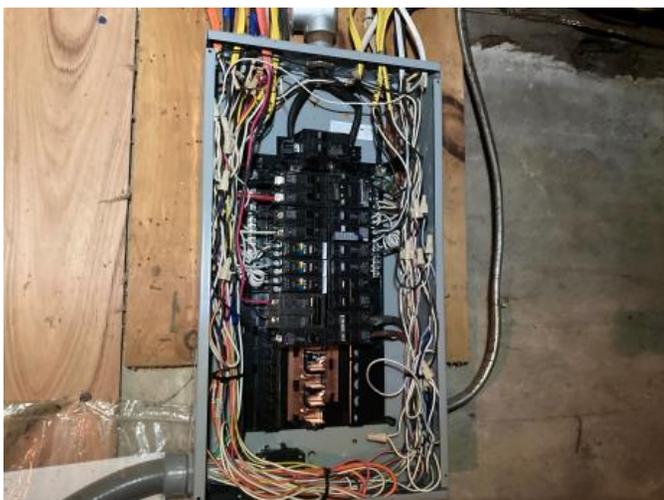
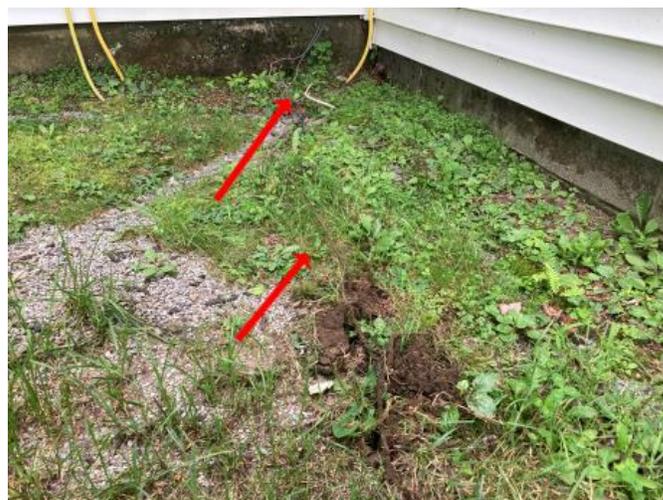
Electrical Panel Conditions (Repair)	5.3	A wire in the panel box appears undersized for the attached circuit breaker. A 14-gauge wire is attached to a 20 Amp Breaker. The grounding wire, located outside to the left of the front entrance, appears to be frayed and damaged. Recommend further evaluation by a licensed electrician prior to close.
--------------------------------------	-----	---

Grounding wire appears damaged.

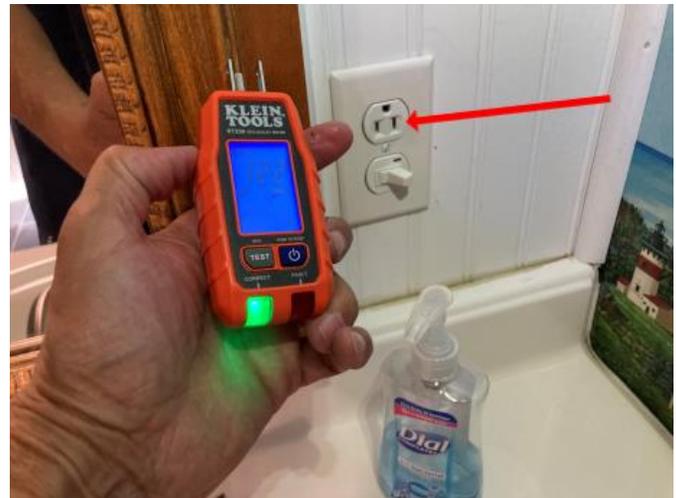
Electrical Conditions (Safety)	9.7	GFIC (Ground Fault Interrupter Circuit) receptacle circuit (a safety device for outlets near water) recommended in bathroom to protect against electrical shock. One outlet (by light switch) tested to have an open ground. Recommend necessary repairs by a qualified contractor.
-----------------------------------	-----	---

Outlet not GFCI protected.

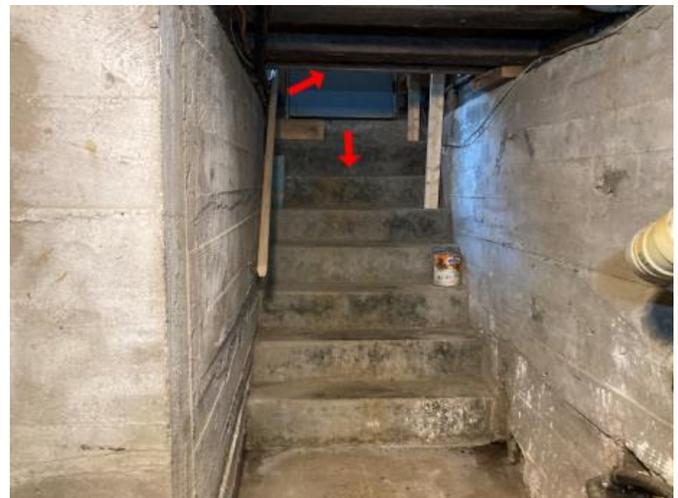
Low head room and inconsistent step rise.

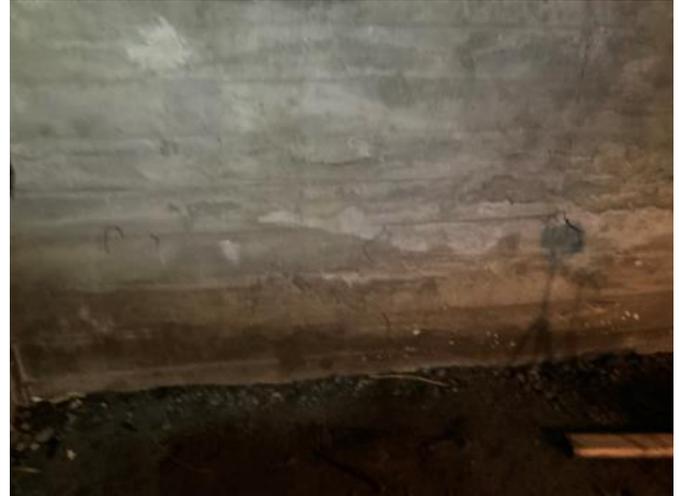
Basement walls show signs of moisture intrusion. Staining and efflorescence present on walls. This is common on older homes with foundation walls of stone/concrete. Recommend further evaluation and necessary repairs by a qualified contractor to help seal walls.

Efflorescence.

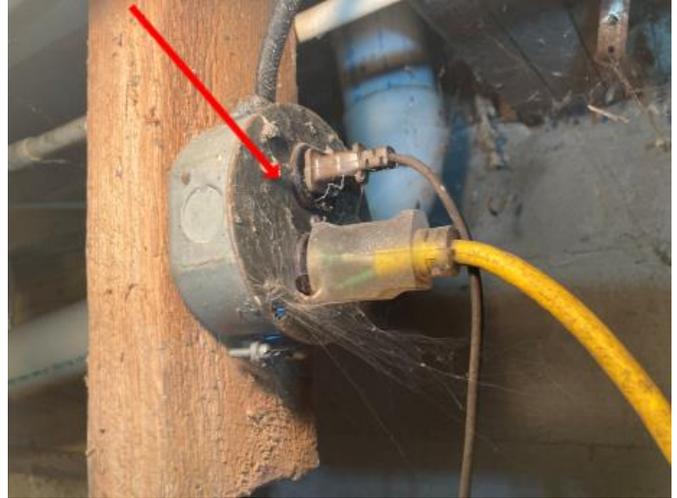
Outlet not GFCI protected.

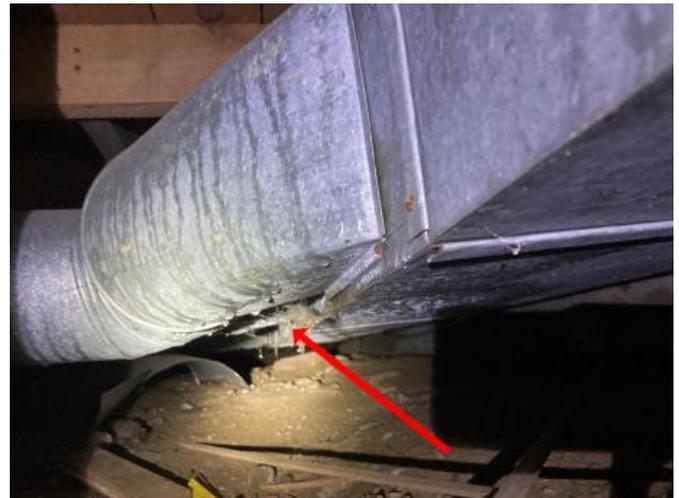
Crawl space was not entered. Inspector could not make entry due to the small access hole. Some water condensation was noted on the duct work in the crawl space. On the day of inspection, it was hot and humid which could result in the condensation observed. Placing a vapor barrier (plastic) down in the crawl space might help as well as improving basement ventilation. Recommend further evaluation and necessary repairs by a qualified contractor.

Condensation on ducting in crawl space.

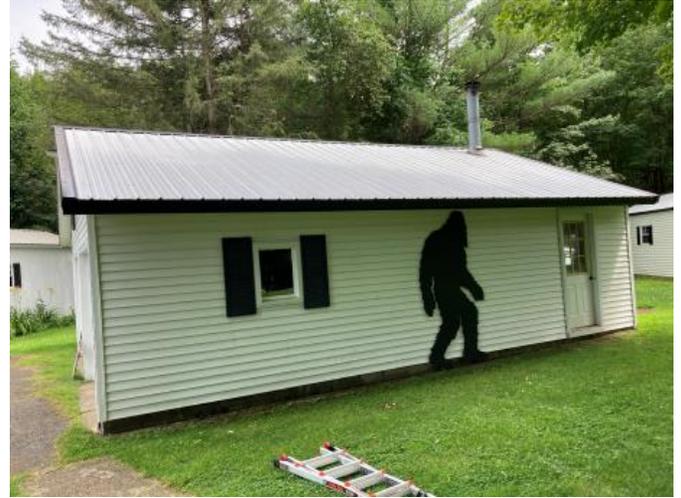
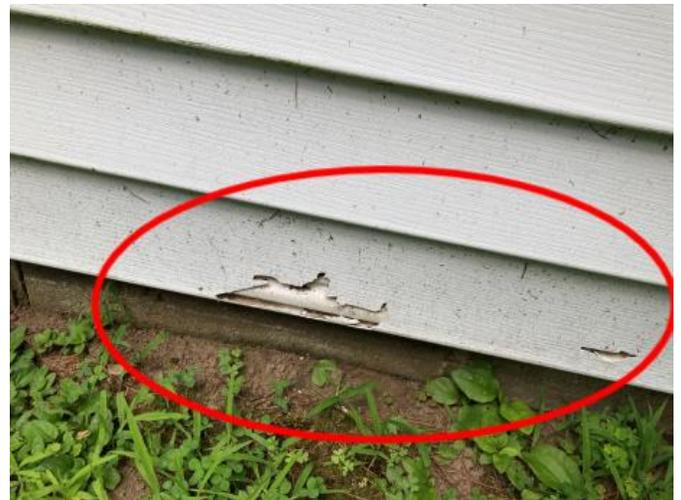
Some siding damage noted close to the ground. This can allow moisture intrusion and water damage. Recommend necessary repairs by a qualified contractor.

Siding damage.

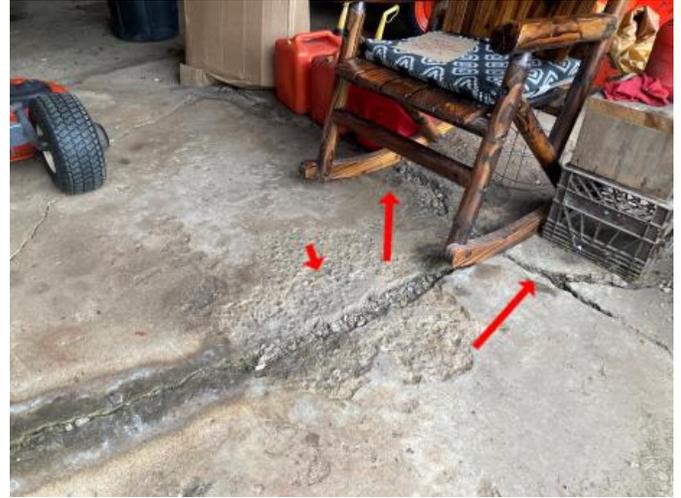
Cracks and some Spalling on floor.

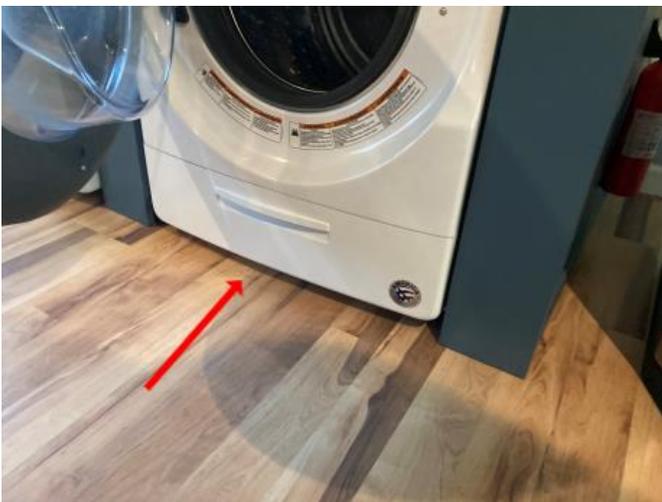
No washing machine pan noted.
