Inspection Report

1 Good Home Inspection

Inspector: William Stowell

Inspection Date August 4, 2022

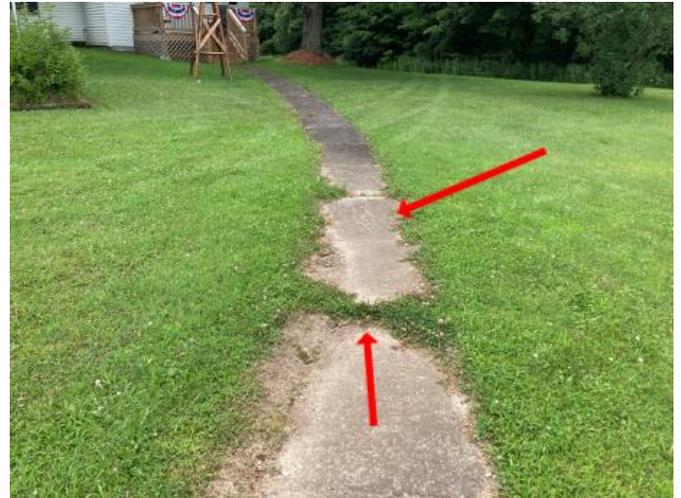
Appears Serviceable. Recommend removing any vegetive growth which might cause premature failure of concrete.

Concrete walk showing some vegetation overgrowth.

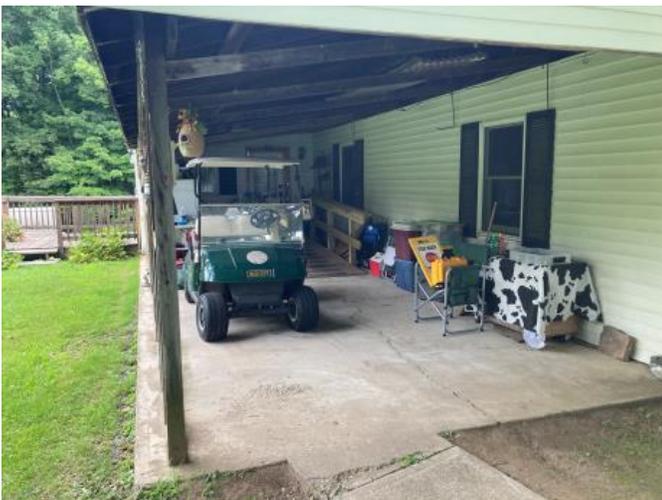
Rear entry covered patio concrete slab has some cracks. Cracks don't appear to be a trip hazard. Would recommend maintenance of filling cracks with urethane caulking to keep water from penetrating.

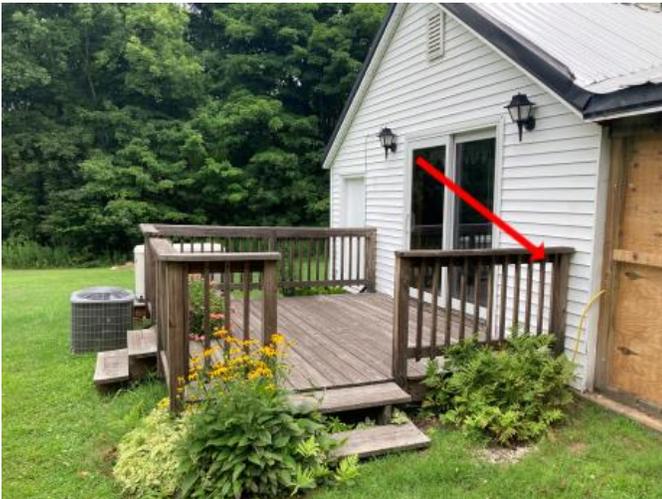
Guardrail Condition (Repair)	1.6	Rear deck has a loose guard rail post next to the house on the right side. This can allow the railing to fail resulting in a possible fall hazard. Recommend necessary repairs by a qualified contractor.
Exterior		
Front Entrance Conditions (Repair)	2.1	The front entrance decking ledger board is nailed to the house. Recommend using approved lag screws. Rim joists are nailed to the support posts. Recommend using approved lag bolts/screws. Floor joists are missing joist hangers. These corrections will help ensure the deck doesn't fail. Recommend necessary repairs by a qualified contractor.
Exterior Wall Conditions (Repair)	2.3	A few cracks and holes found in siding. These can allow moisture intrusion. Recommend necessary repairs by a qualified contractor. and damage to inner wall covering.
Exterior Door Conditions (Safety)	2.6	Door to rear patio has low headroom. It's only 70 inches tall. Standard door is 80 inches. All exterior doors (except the one leading to basement) have dead bolts that are keyed from the inside. This is a safety egress issue in an emergency (I.e: fire). Recommend necessary repairs by a qualified contractor.

Rear deck - loose guard railing

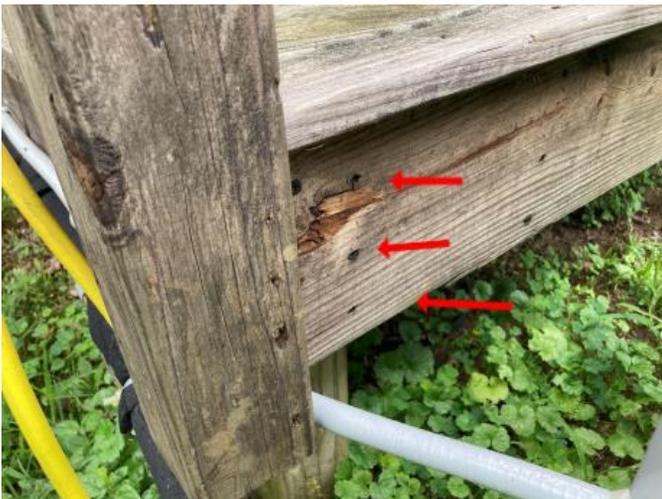
Appears Serviceable. However, the ledger board and support beams are nailed to the house and support posts. It is recommended these be fastened with approved lag screws. Recommend necessary repairs by a qualified contractor.

Nails holding rim joist to support post.

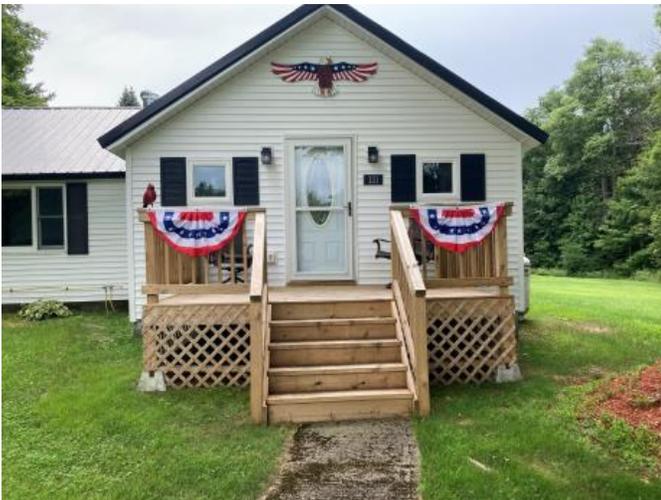
The front entrance decking ledger board is nailed to the house. Recommend using approved lag screws. Rim joists are nailed to the support posts. Recommend using approved lag bolts/screws. Floor joists are missing joist hangers. These corrections will help ensure the deck doesn't fail. Recommend necessary repairs by a qualified contractor.

No joist hangers on front entrance porch deck

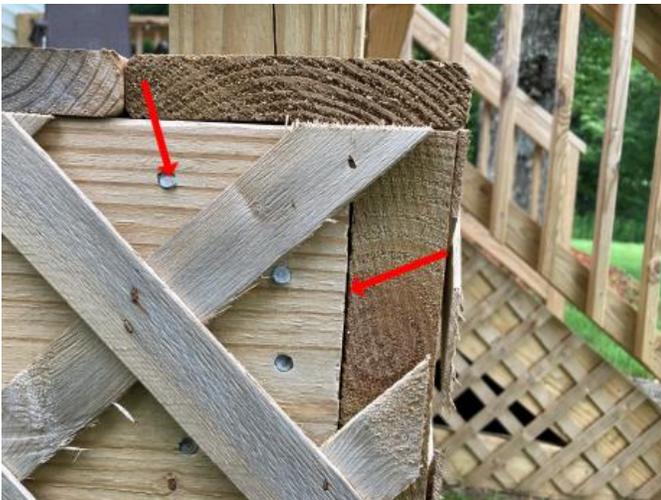
Rim joists nailed to support posts.

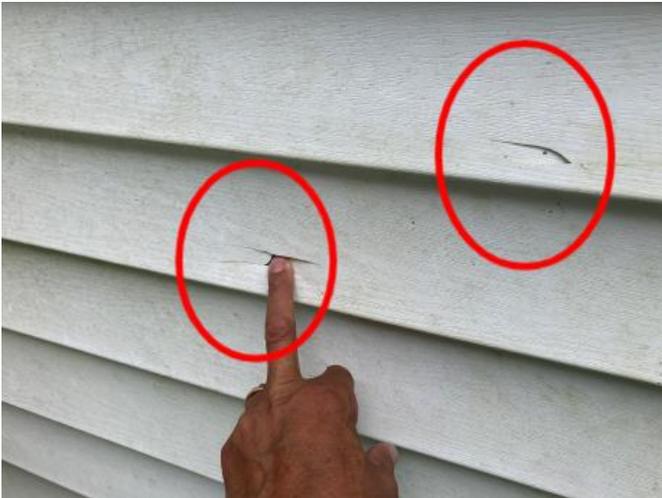
A few cracks and holes found in siding. These can allow moisture intrusion. Recommend necessary repairs by a qualified contractor. and damage to inner wall covering.

Cracks in siding

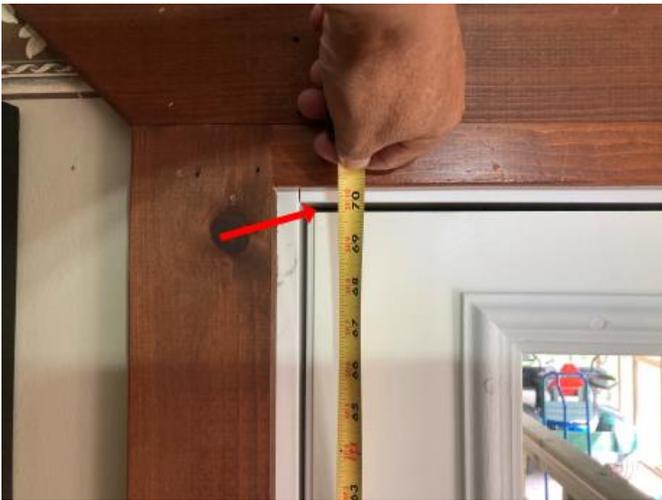
Door to rear patio has low headroom. It's only 70 inches tall. Standard door is 80 inches. All exterior doors (except the one leading to basement) have dead bolts that are keyed from the inside. This is a safety egress issue in an emergency (i.e: fire). Recommend necessary repairs by a qualified contractor.

Door to rear patio only 70 tall. Standard is 80 inches.

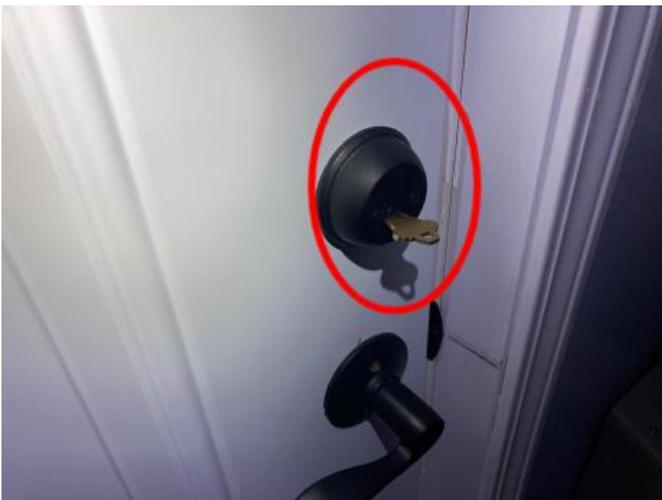
Dead bolt keyed from inside.

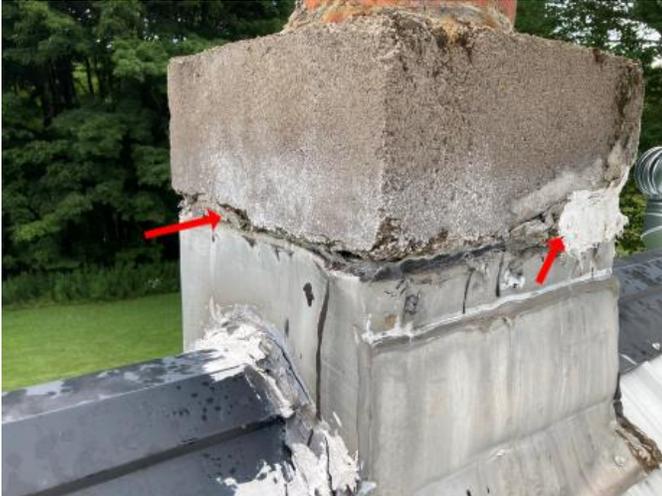
Some loose mortar/sealant noted. This can allow moisture intrusion and damage. Recommend necessary repairs by a qualified contractor.

Loose mortar and sealant on Chimney

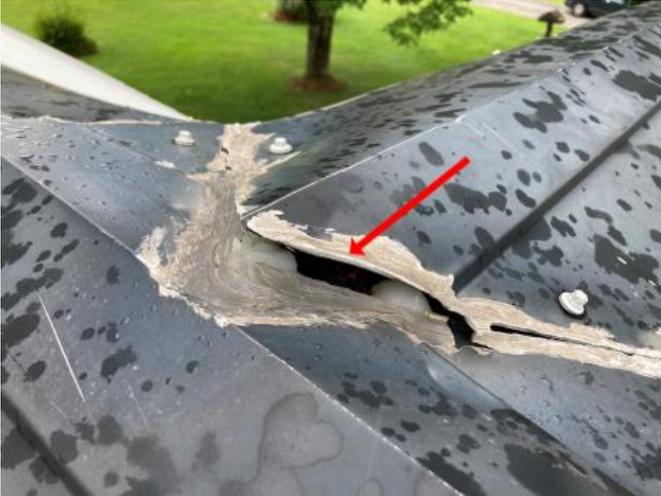
Observed some damaged gable end roof trim and some loose metal roofing. This may have been from ice damming (see sample picture). Ridge cap is in need of sealing. Roof metal was incorrectly lapped during install. A hole was observed around one of the metal roof fasteners. These can lead to water intrusion and damage. Recommend further evaluation and necessary repairs by a qualified contractor.

Ridge cap needs sealing

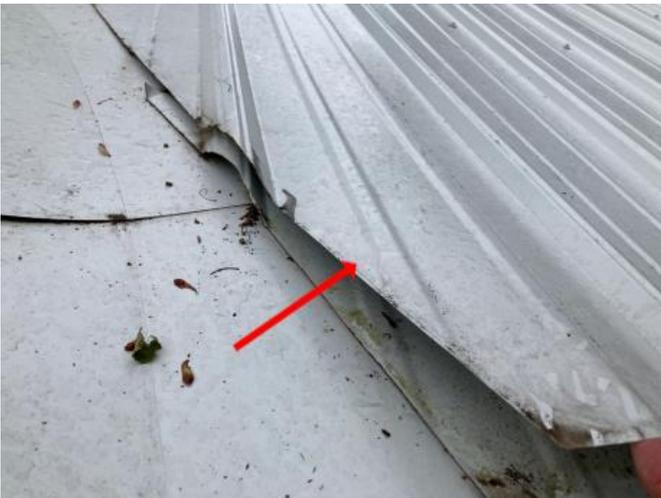
Roof metal needs to be fastened

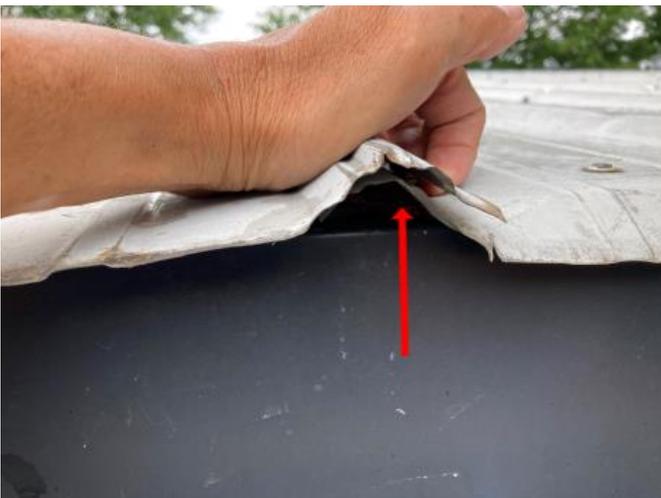
Steel roofing was lapped incorrectly when installed.

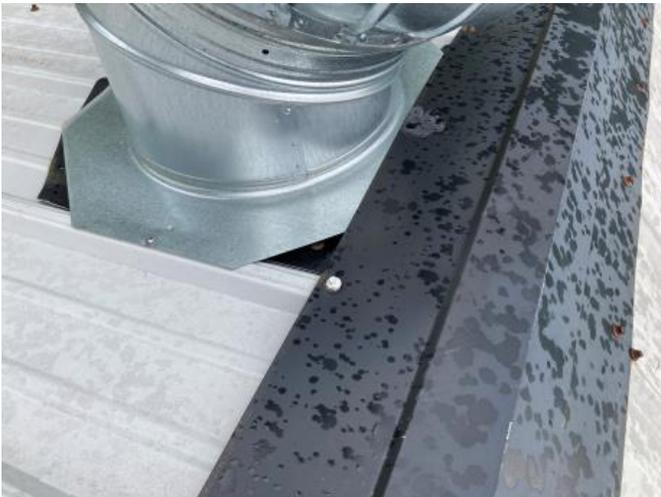
The exposed flashings appeared to be in serviceable condition at the time of inspection. However, the rubber boot flashing around the electrical entrance mast was lifted and the flashing around the attic roof vents are areas prone to leaks. Recommend monitoring these areas for leaks and contacting a roofing contractor if needed to make repairs.

Attic Roof Vent flashing

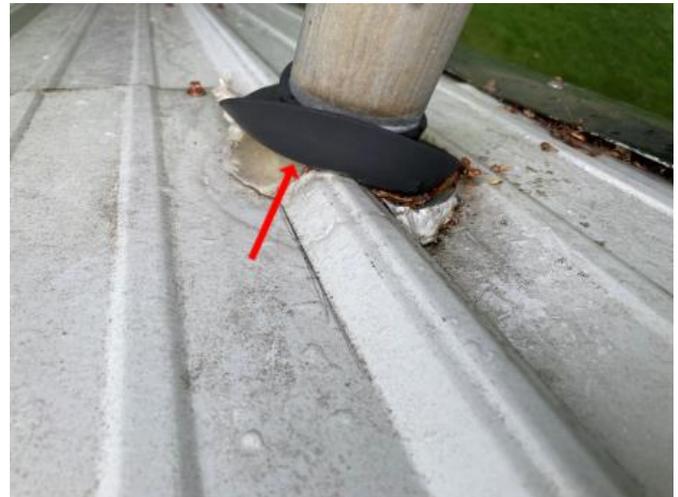
Electrical Entrance Mast flashing "lifted"

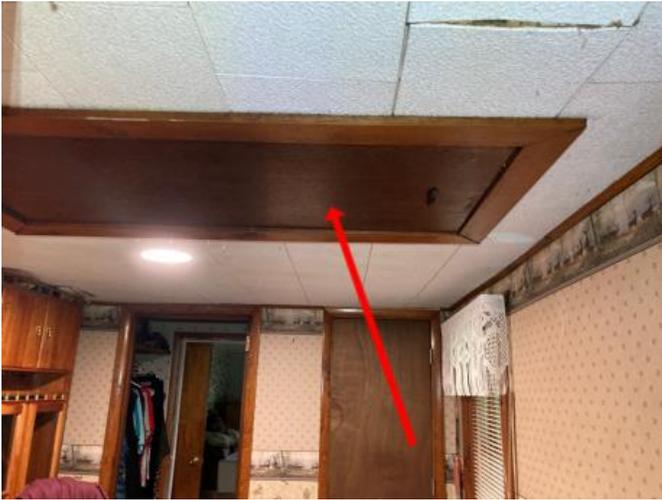
Pull down attic stairs in small office area.

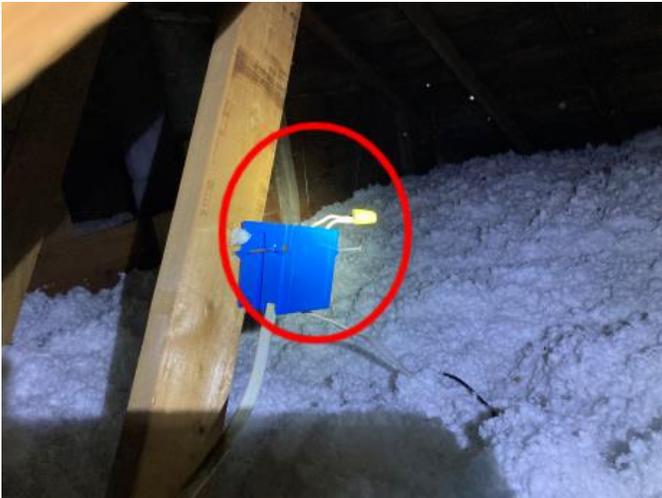
The visible and accessible portions of the attic appeared to be in serviceable condition at the time of the inspection. An electrical box was not covered. Recommend covering the box for safety. Recommend necessary repairs by a qualified contractor.

No cover on Junction Box.

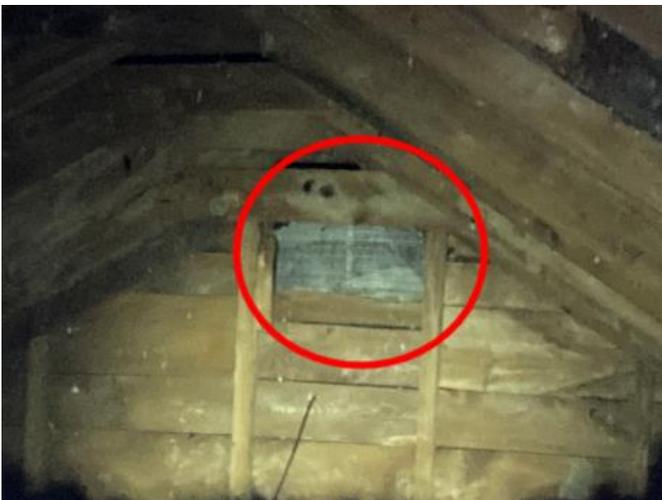
Minimal ventilation was provided to the attic area. This may not be sufficient to move air through the attic properly. Recommend installing additional vents. Recommend further evaluation and necessary repairs by a qualified contractor.

Gable end vent

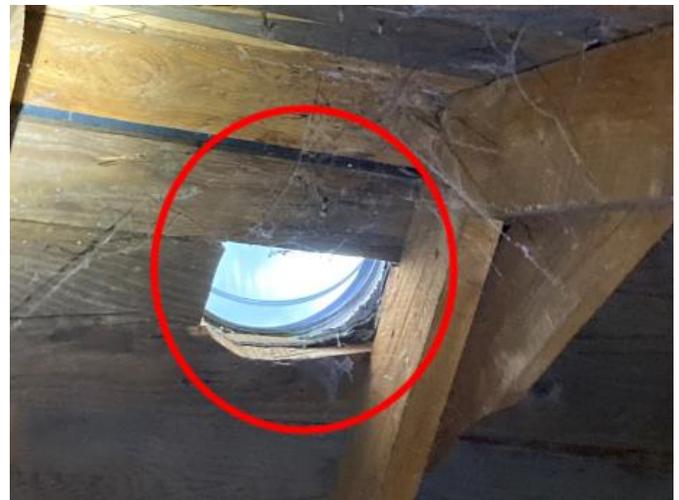
Roof Vent.

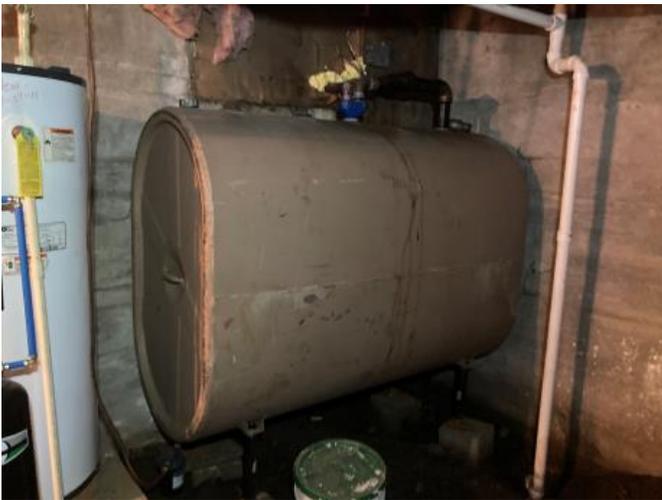
Fuel oil tank

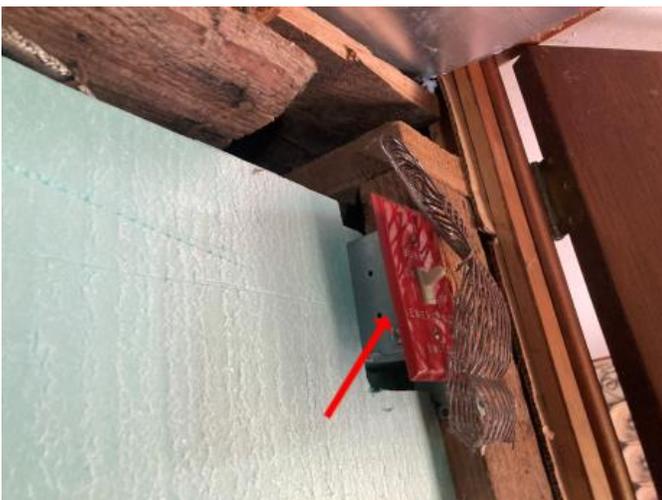
Emergency Shut Off for Furnace - Top of Basement Stairs.

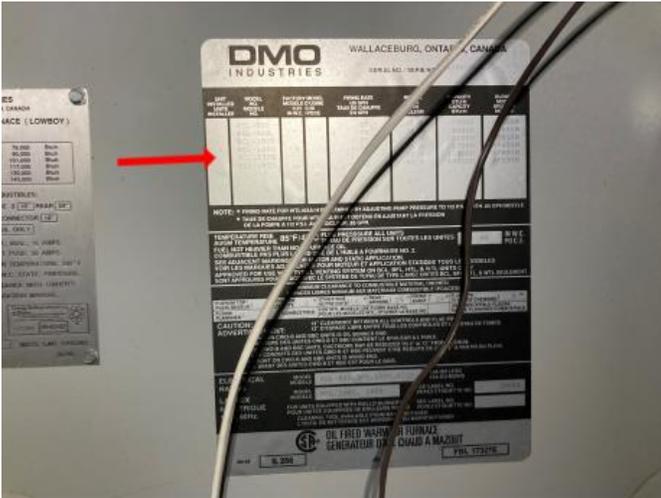
Data Plate on Furnace

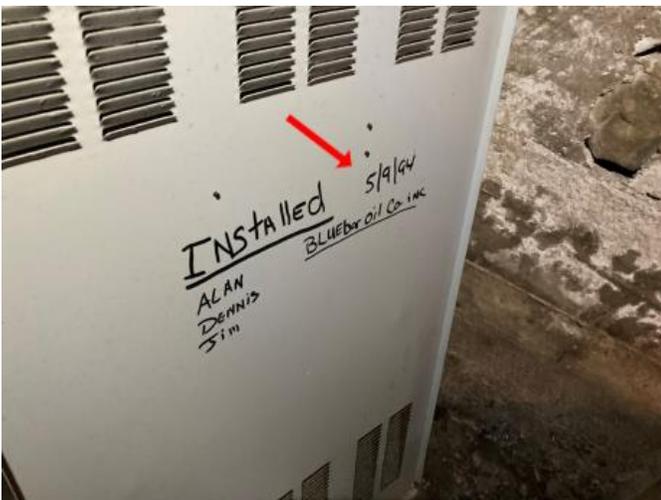
Unit had a damaged air filter. Unit had a 1994 Install date handwritten on the cover. Data label had manufacture testing date of 1989. It didn't appear there was a place (bracket) to properly hold the filter. No filter track / holder was noted. In order for the filter to be effective, recommend installation of a filter track. Recommend necessary repairs by a qualified contractor.

Handwritten install date.

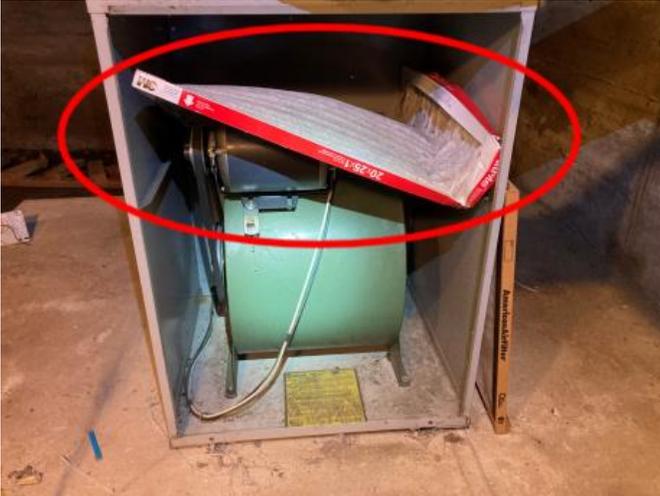
Furnace filter with no holding rack.

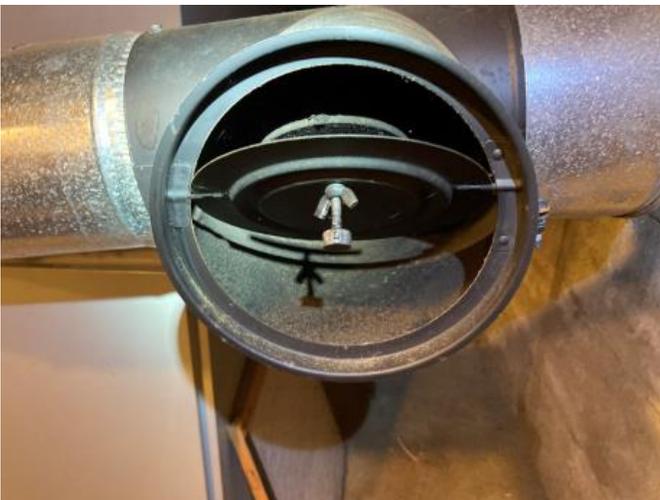
Furnace vent pipe draft control gate was sticking. This needs to be able to move freely for proper draft control. Recommend necessary repairs by a qualified contractor.

Draft control sticking

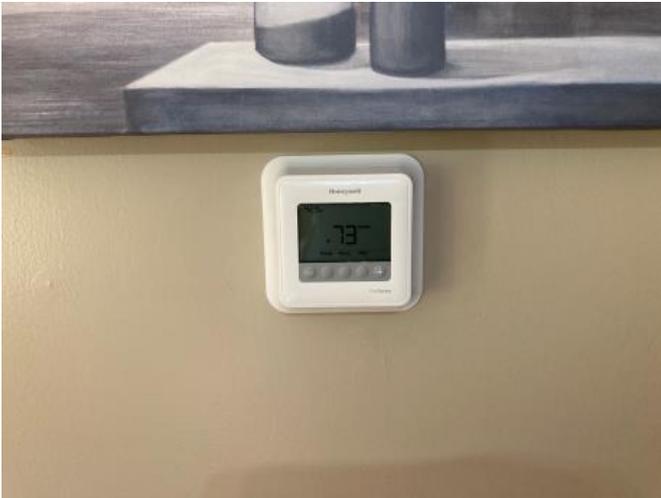
Furnace and air conditioning thermostat.

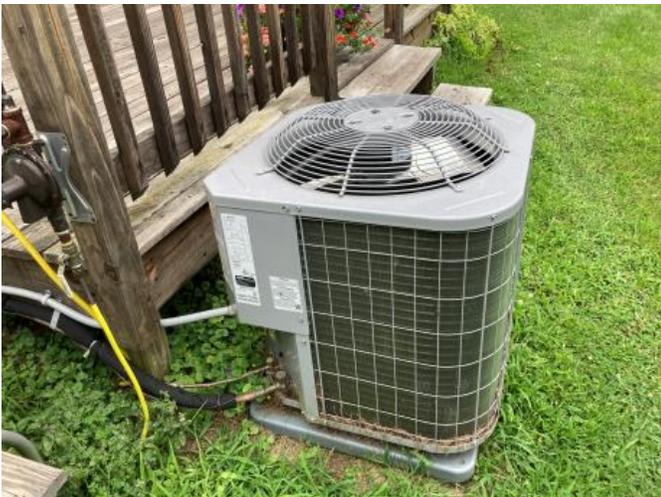
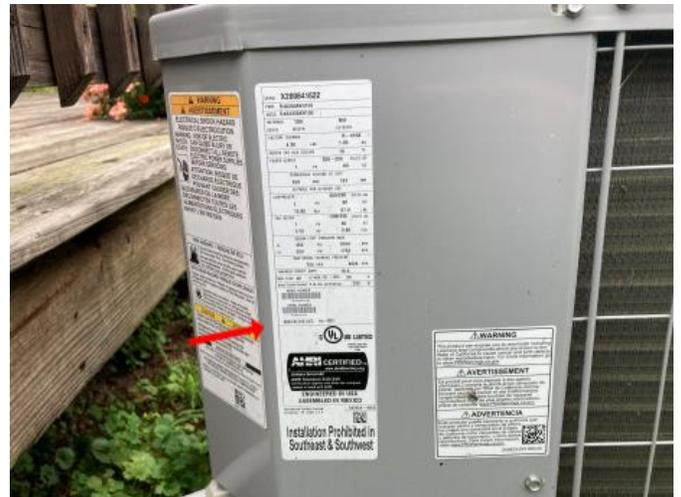
Manufacture date = 2020

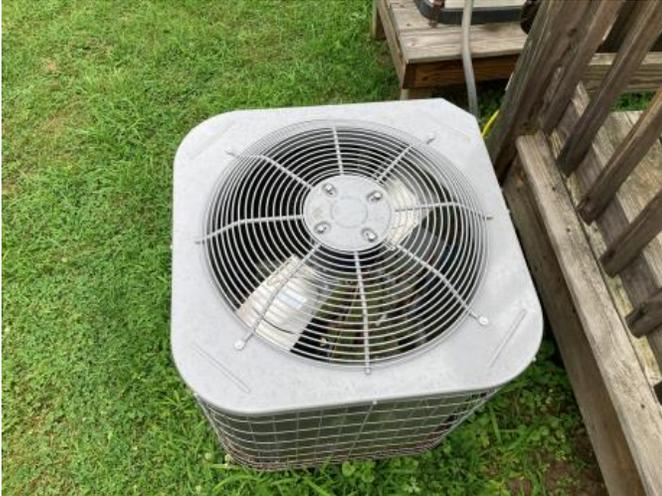
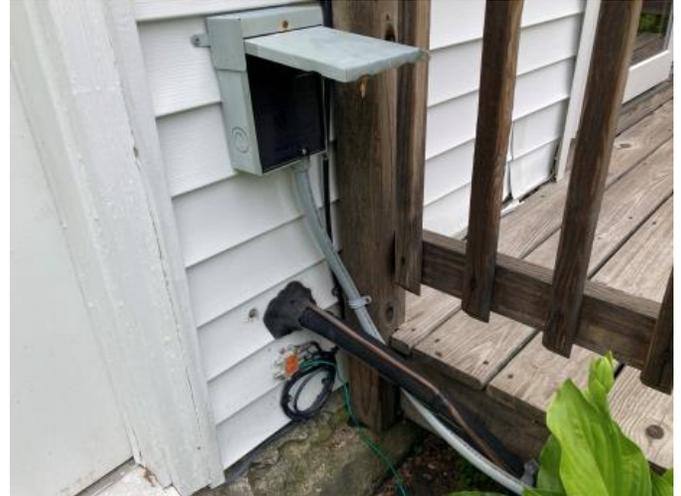
AC during operation

System sounds acceptable

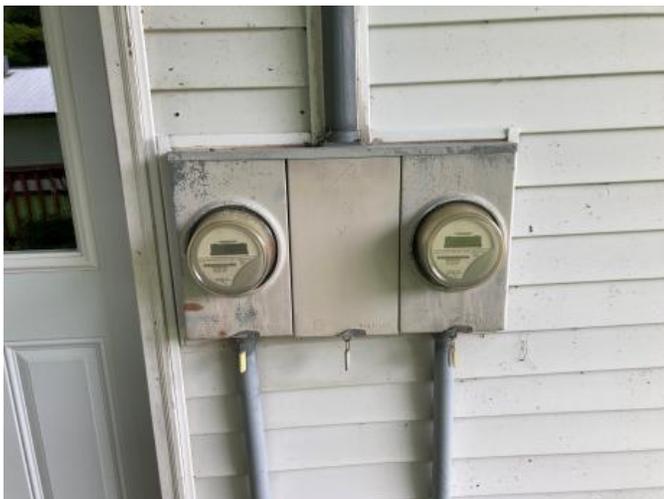
Two electrical meters present. According to the owner, there was trailer in the back yard on its own electrical service and one time but is now disconnected. Service entrance mast appeared bent but serviceable and had a cable securing it to the roof to prevent further bending to the mast.

Duel electrical meters

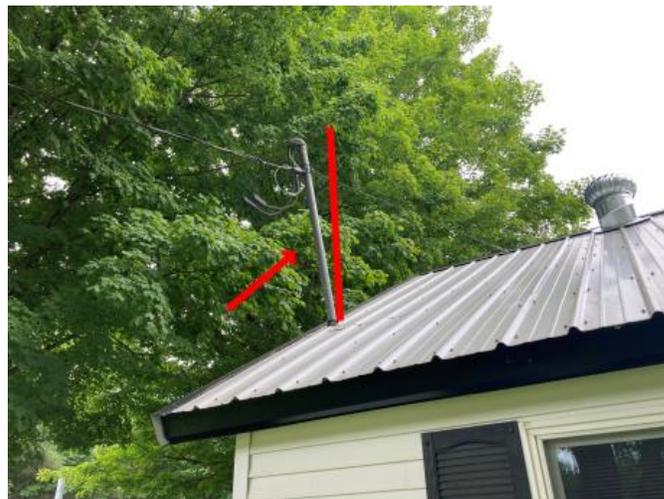
Service Entrance Mast Bent

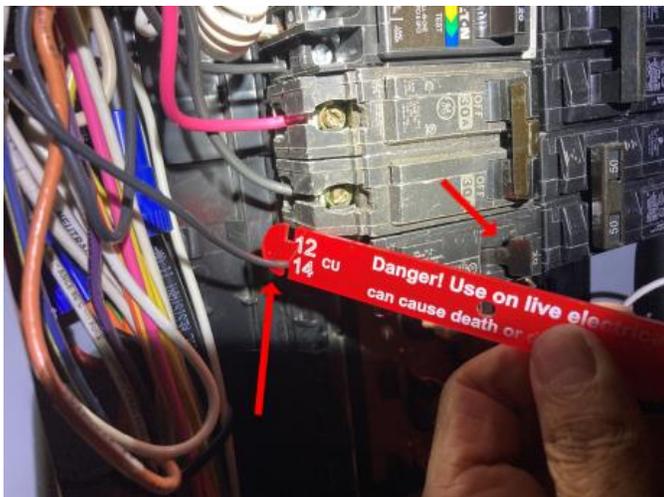
A wire in the panel box appears undersized for the attached circuit breaker. A 14-gauge wire is attached to a 20 Amp Breaker. The grounding wire, located outside to the left of the front entrance, appears to be frayed and damaged. Recommend further evaluation by a licensed electrician prior to close.

14 gauge wire attached to 20 Amp Breaker.

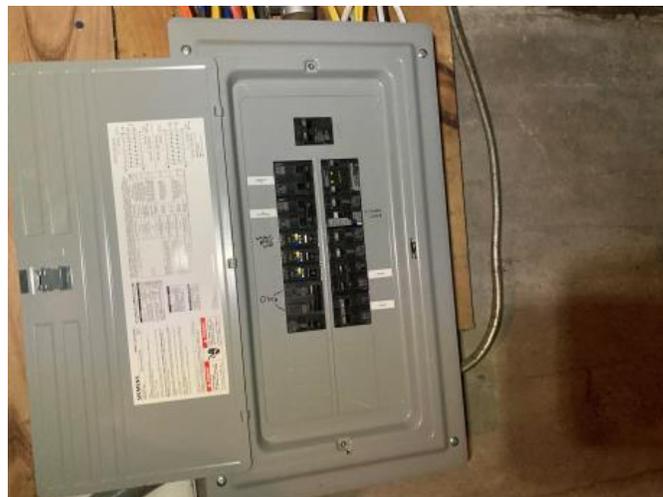
Grounding wire appears damaged.

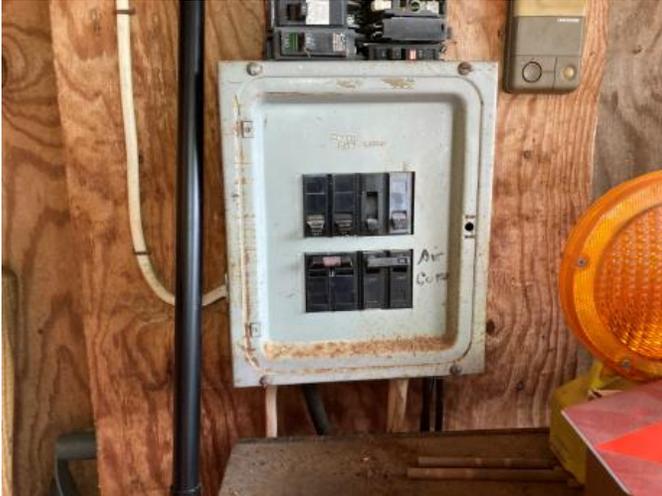
Garage subpanel was fed from the house with two hot and one neutral wire. No 4th grounding wire was noted going back to the house nor was a grounding wire/rod noted at the garage. A three-wire connection was present at the sub panel. A separate fourth ground / neutral wire was not connected from the main panel to the sub panel. Although the present condition may have been proper at the time the sub panel was installed, today's standards use an additional ground or neutral wire from the main to the sub. Recommend necessary repairs by a qualified contractor.

Garage electrical subpanel

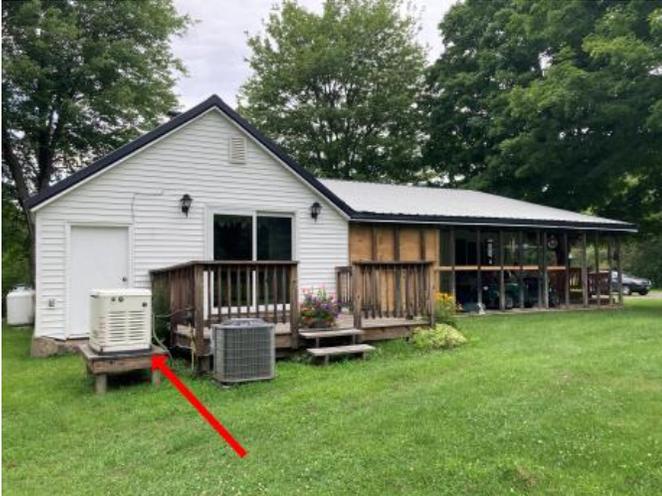
Standby Electrical Generator

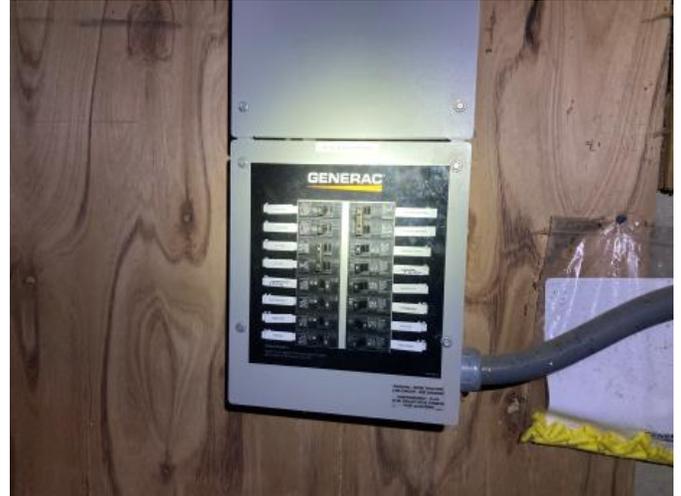
Standby Generator panel.

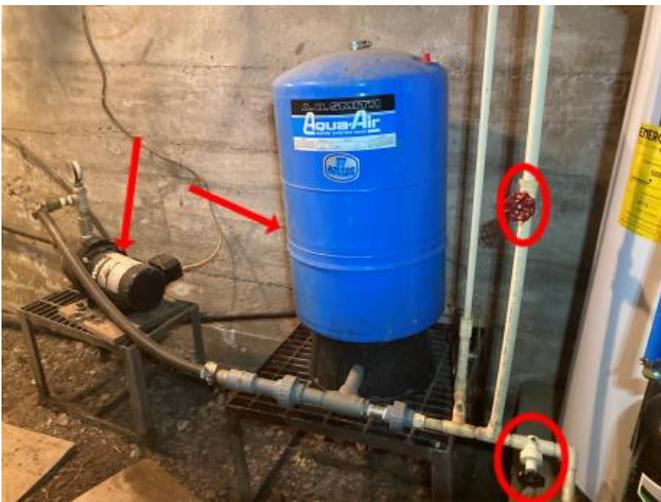
Shallow well pump and pressure tank. Two main water shut off valves.

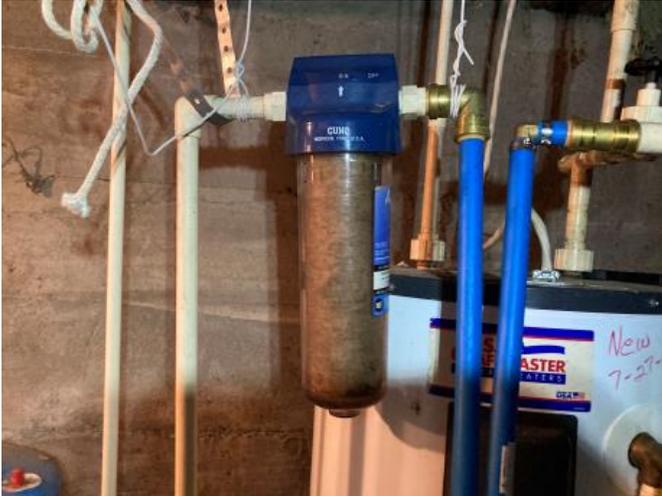
Whole house filter.

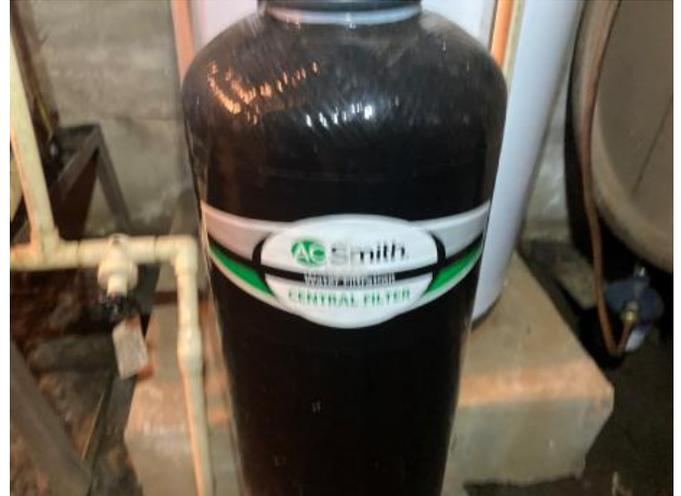
Water Filter

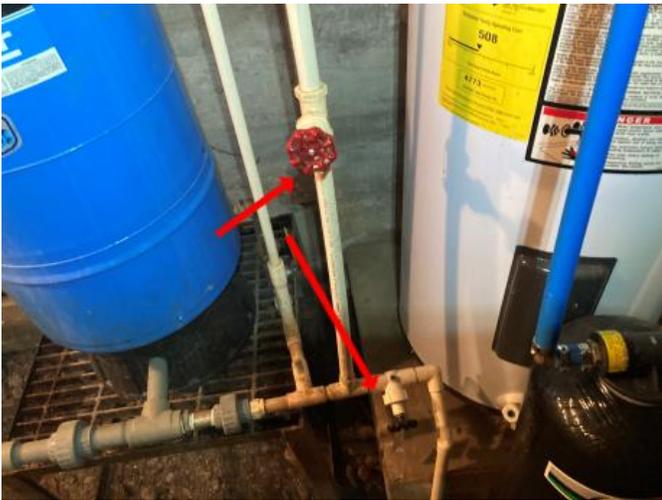
Water shut-off valves.

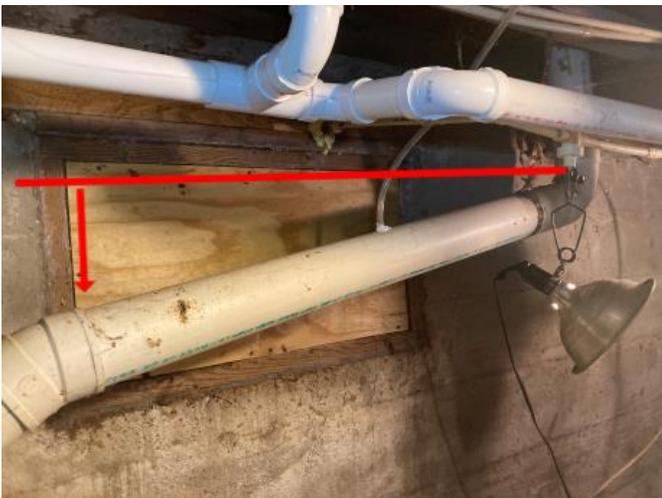
Due to conditions observed or the main drainpipe exit location, a septic system and/or drywell may be, or MAY HAVE BEEN present at one time. Septic system verification, testing and evaluation are outside the scope of this inspection. Client is advised to consult with a homeowner for verification and / or a licensed septic certification specialist. The main waste line appears to have insufficient pitch (too steep) for adequate drainage. Recommend further evaluation by a licensed plumber.

Drain line pitch too steep.

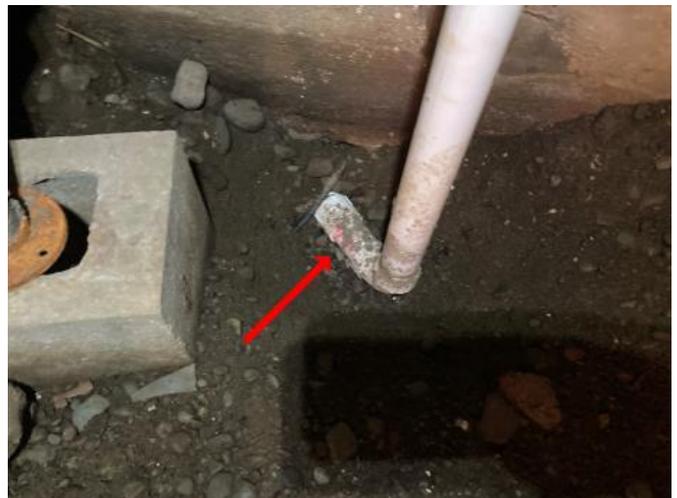
Drain exiting basement at wall base. Perhaps to a drywell??

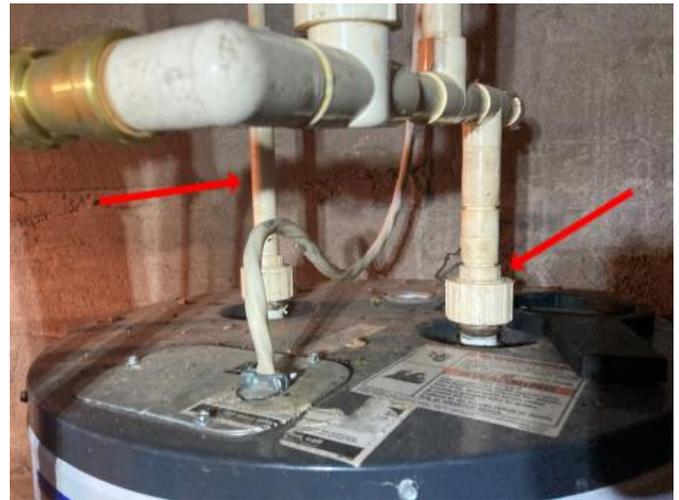
Plastic intake/outtake lines are attached directly to the top of the water heater. Heat can damage these plastic pipes causing failure. Recommend installing metal lines at least 18" above tank. (see SAMPLE photo). Recommend necessary repairs by a qualified contractor.

Plastic piping attached too close to heater.

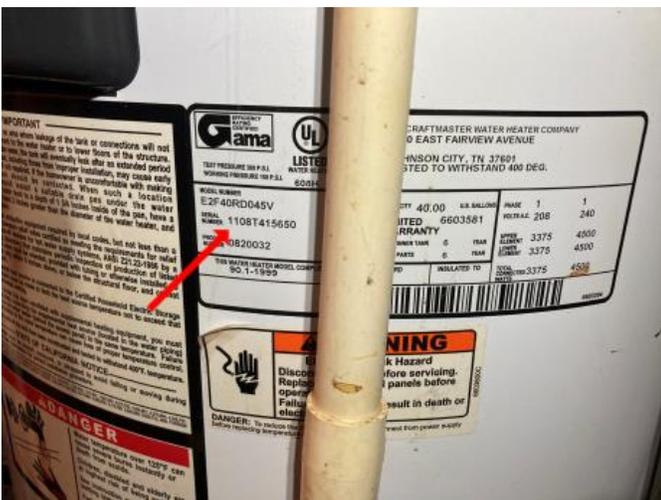
Data label indicates 2011 manufacture date.

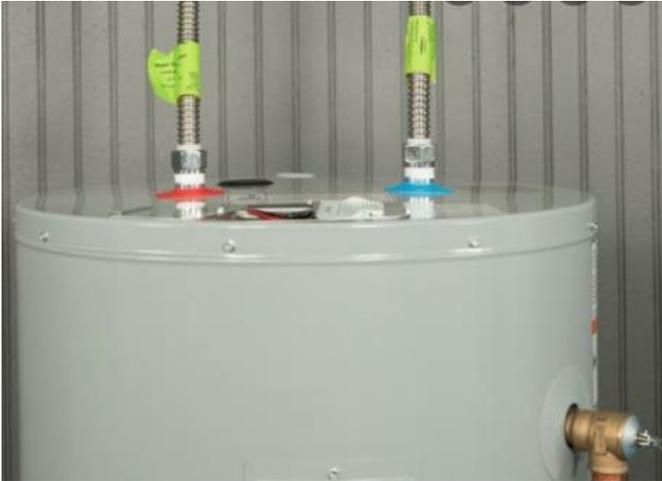
SAMPLE water heater connection lines

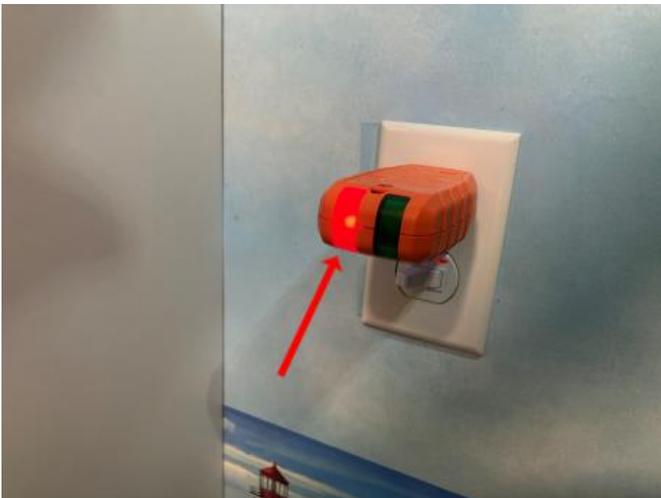
GFIC (Ground Fault Interrupter Circuit) receptacle circuit (a safety device for outlets near water) recommended in bathroom to protect against electrical shock. One outlet (by light switch) tested to have an open ground. Recommend necessary repairs by a qualified contractor.

Open Ground

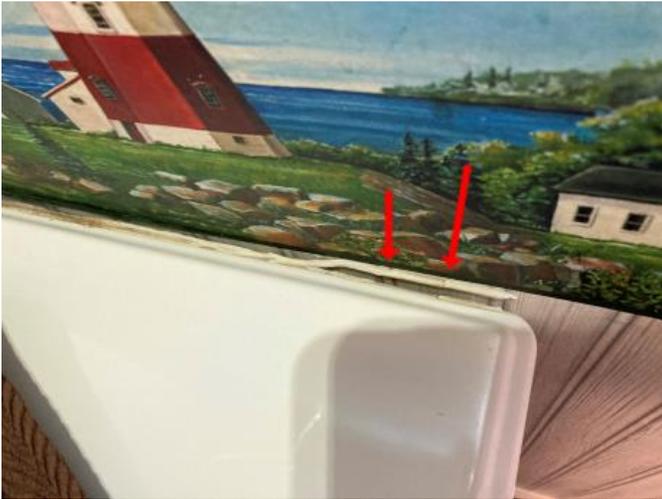
Caulking is coming loose where sink top meets the wall. This can allow moisture intrusion and water damage. Recommend necessary repairs by a qualified contractor.

Caulking loose where sink top meets wall.

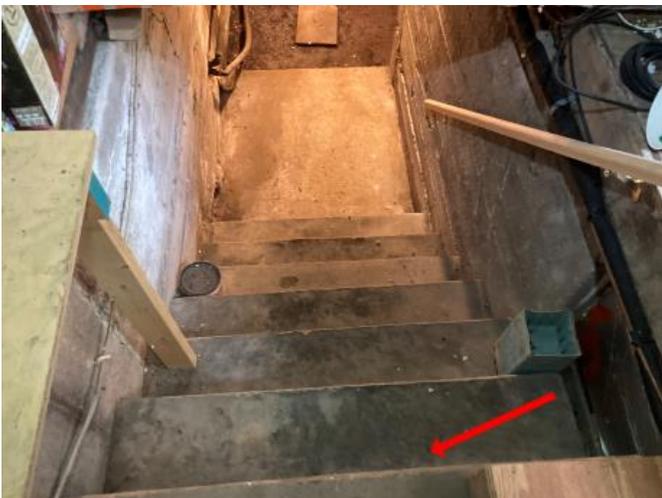
Appears Serviceable. Should note that the house was built in the 1900's. Head room as you enter the basement is low and the steps have inconsistent riser height. Care must be taken when entering the basement as not to hit your head or fall down steps.

Inconsistent step riser height.

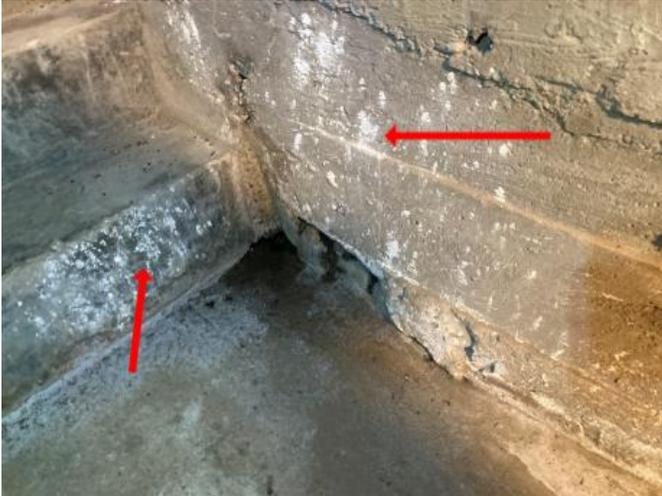
Basement walls show signs of moisture intrusion. Staining and efflorescence present on walls. This is common on older homes with foundation walls of stone/concrete. Recommend further evaluation and necessary repairs by a qualified contractor to help seal walls.

Efflorescence.

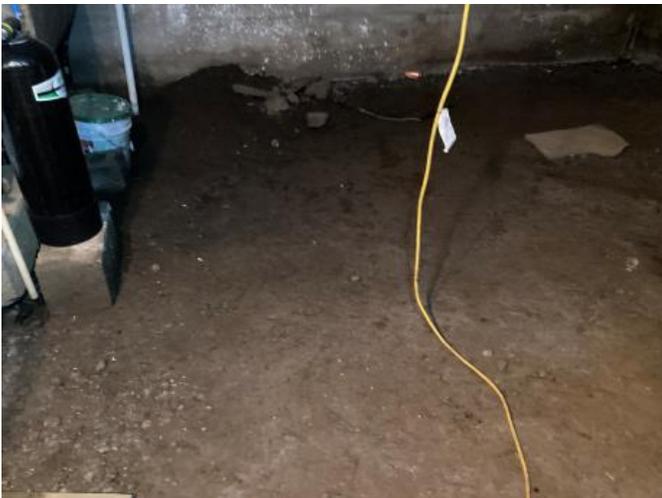
Basement floor was damp and appears to be a dirt floor. Gutters to keep water away from foundation might help with the damp basement floor. Installation of a poured concrete floor and a sump pump might also help with the moisture issues. Recommend necessary repairs by a qualified contractor.

Basement floor.

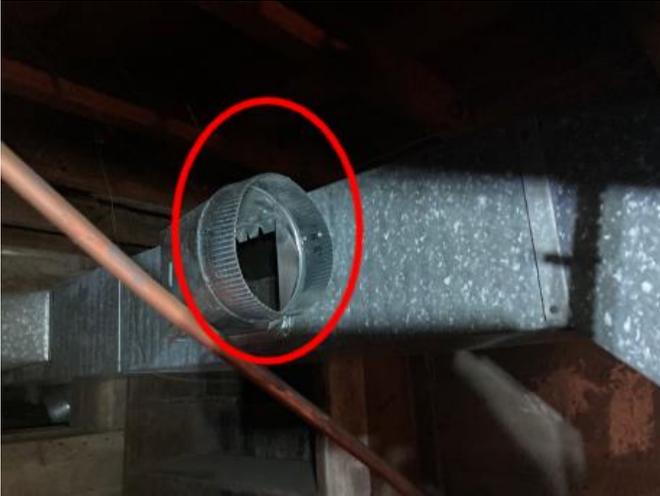
Basement heat duct.

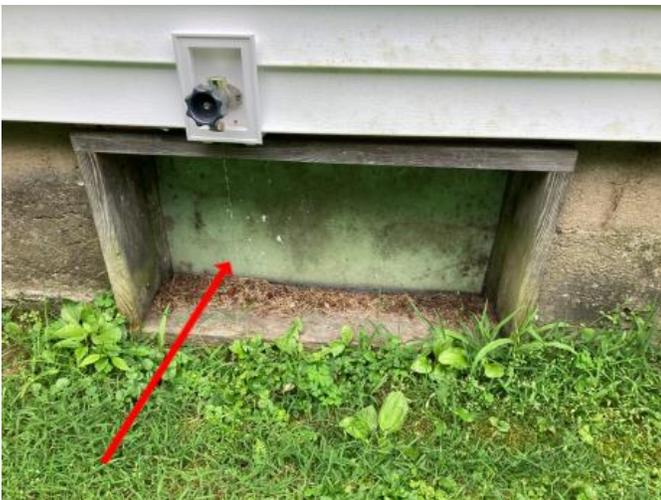
Basement windows have been sealed off and framing needs to be sealed/painted. Windows could help vent the moisture in the basement/crawl spaces. Recommend necessary repairs by a qualified contractor.

Basement window sealed off.

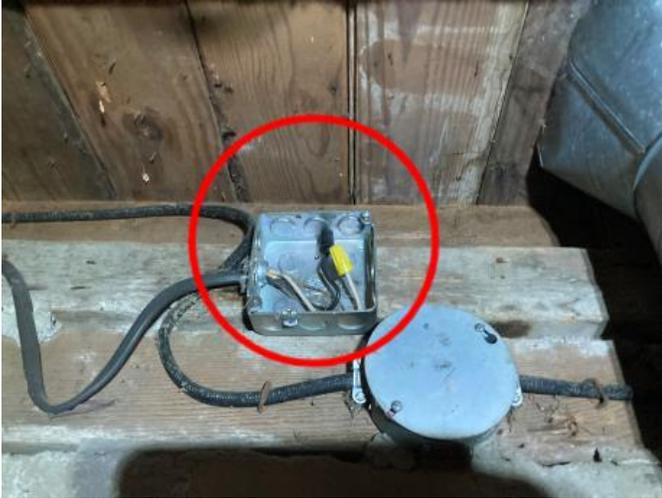
A junction box was missing its cover. Outlets in basement were not GFCI protected as recommended in wet areas like basements to help prevent electrical shock. Recommend necessary repairs by a qualified contractor.

Junction box missing cover.

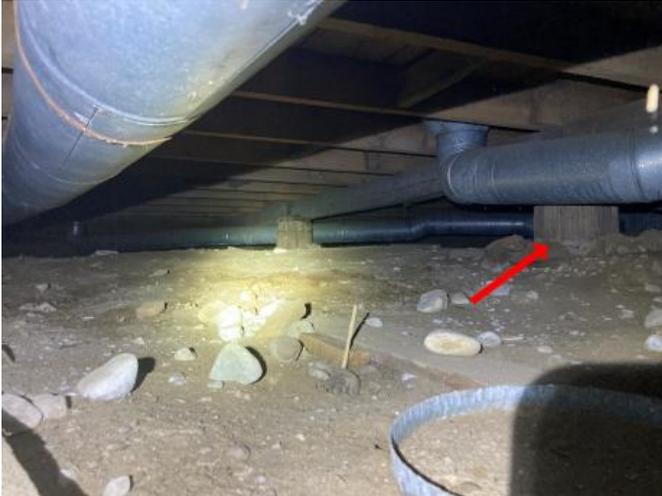
Wood supports for beams in crawl space.

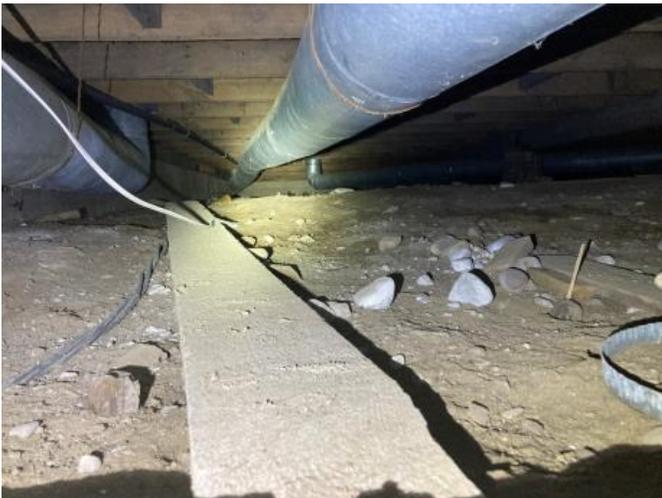
Crawl space was not entered. Inspector could not make entry due to the small access hole. Some water condensation was noted on the duct work in the crawl space. On the day of inspection, it was hot and humid which could result in the condensation observed. Placing a vapor barrier (plastic) down in the crawl space might help as well as improving basement ventilation. Recommend further evaluation and necessary repairs by a qualified contractor.

Condensation on ducting in crawl space.

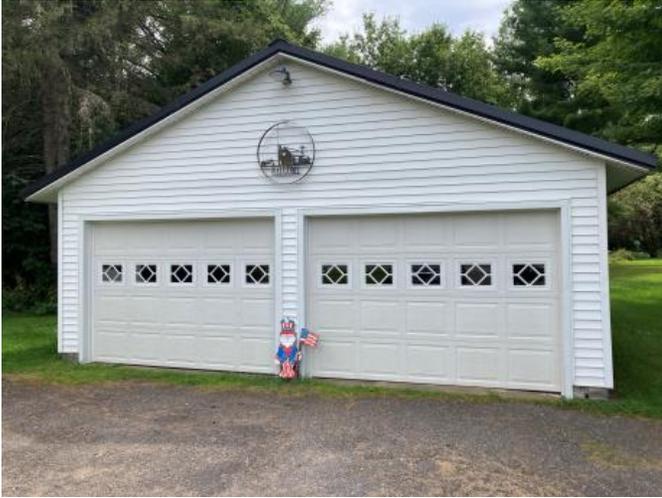
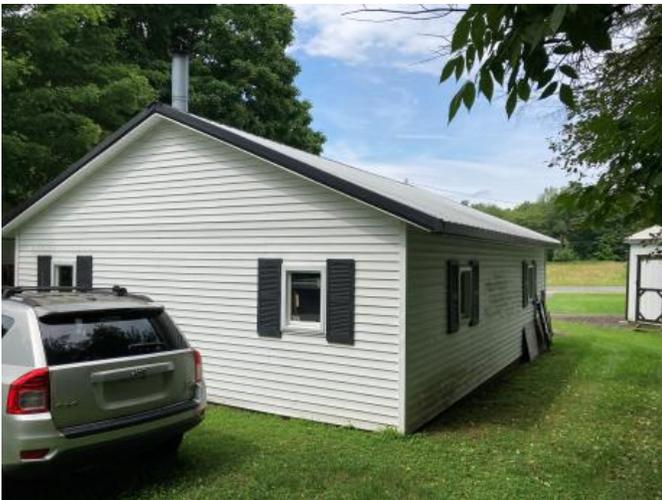
Some siding damage noted close to the ground. This can allow moisture intrusion and water damage. Recommend necessary repairs by a qualified contractor.

Siding damage.

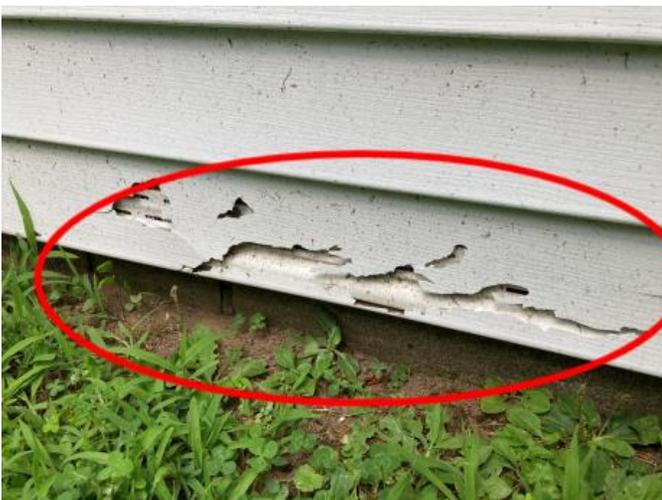
Siding damage

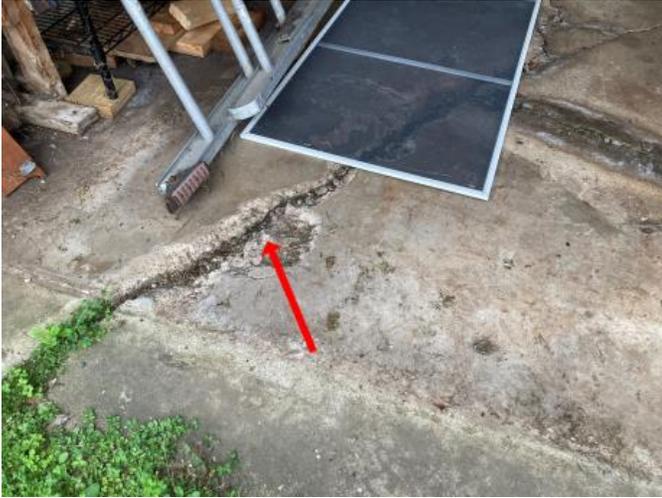
Cracks and settlement were observed to the concrete flooring. Recommend further evaluation by a masonry contractor.

Cracks in garage floor
