Inspection Report

1 Good Home Inspection

Inspector: William Stowell

Inspection Date August 4, 2022

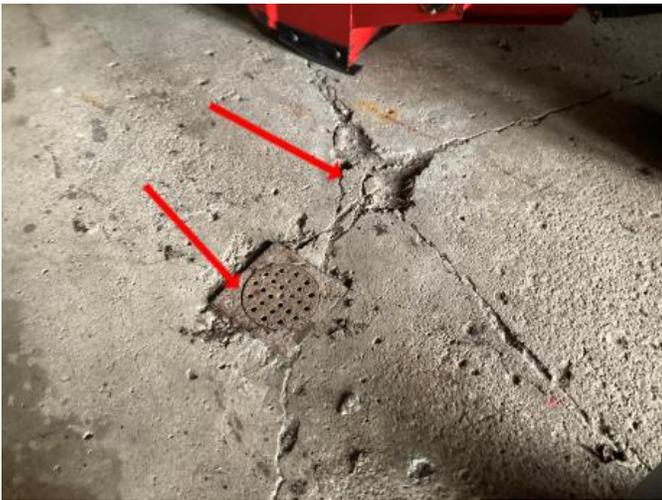
Cracks and settlement were observed to the concrete flooring. Recommend further evaluation by a masonry contractor.

Floor drain and cracks in floor.

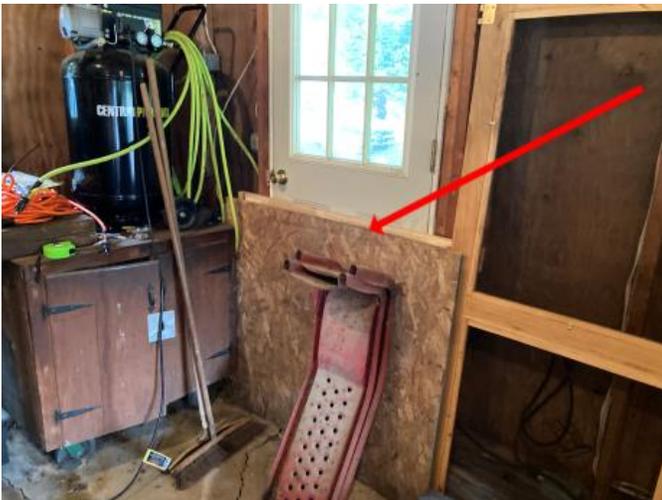
Items stored and leaning against the main door prevent inspection of the door on the day of inspection.

Items stored prevented inspection of man door.

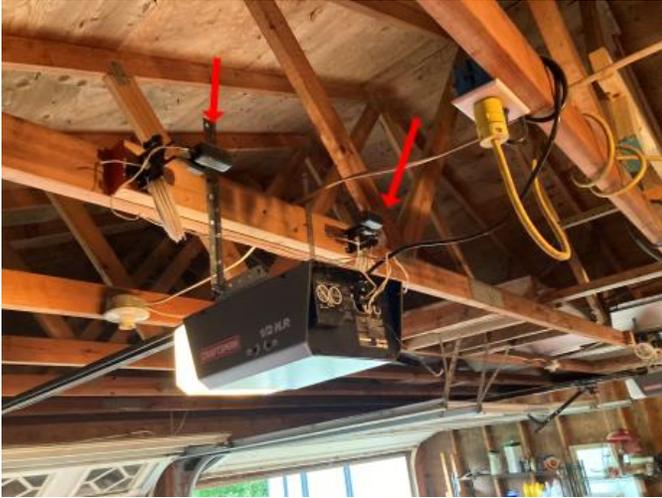
Door operated as designed. However, the electronic safety eye sensors that are supposed to be mounted at the bottom of the doors were mounted on a rafter. This "bypasses" the doors safety feature which stops the door from closing if an obstruction (like a small child) is under the door. Recommend necessary repairs by a qualified contractor.

Electric safety "Eyes" mounted on rafter.

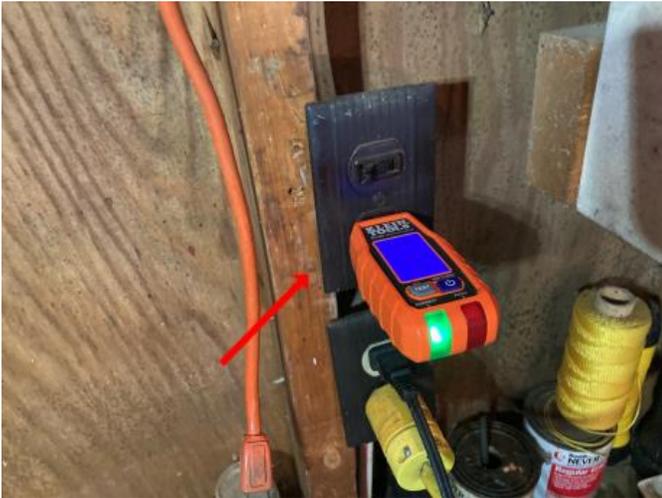
Outlets were not GFCI protected as recommended for wet locations to help prevent electrical shock. Recommend installation of GFCI (Ground Fault Circuit Interrupter) outlets by a qualified contractor.

Outlets are not GFCI protected.

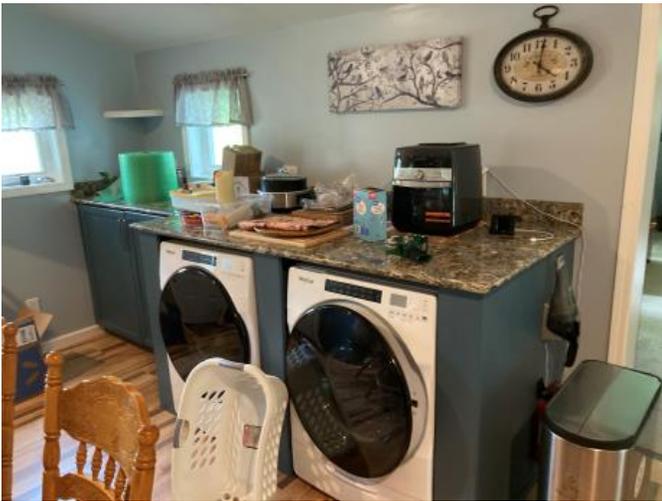
Washing Machine Overflow Pan Missing washer overflow pan.
